APD Status

Leon Mualem

APD Status/Plans

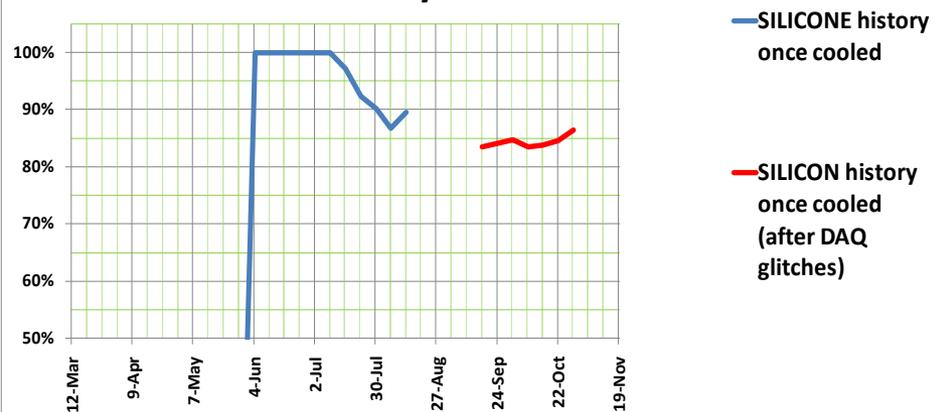
SILICONE history once cooled

- **Silicone**

- 178 installed
- 162 work cold after installation
 - 91%
- 140 continue to work cold today
 - Some after 26 weeks
 - 86% of those which initially worked cold
- 79% of the 178 installed

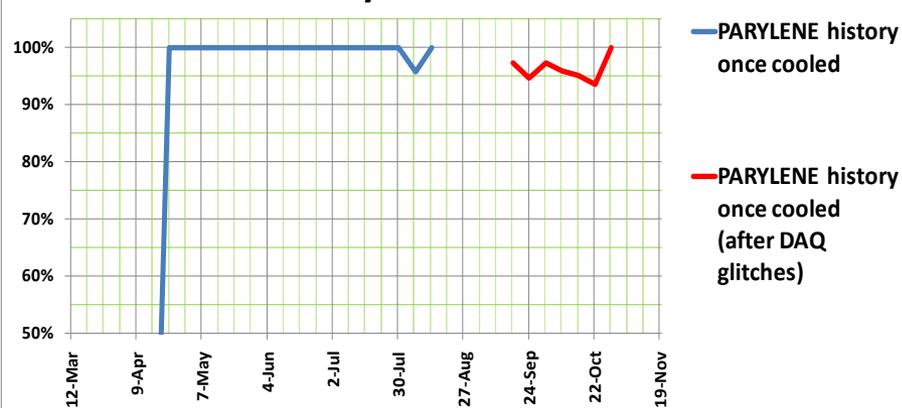
PARYLENE history once cooled

- **Parylene**

- 107 installed
- 92 work cold after installation
 - 86%
- 92 continue to work cold today
 - Some after 33 weeks
 - 100% of those which initially worked cold
 - But not necessarily the same ones
 - 86% of the 107 installed

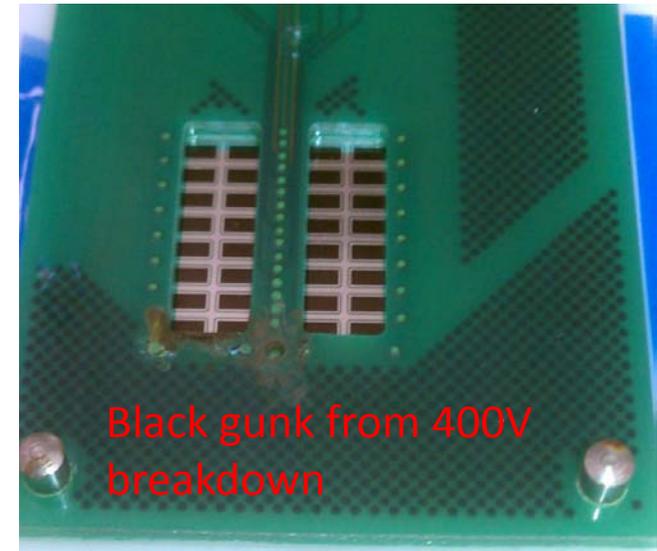
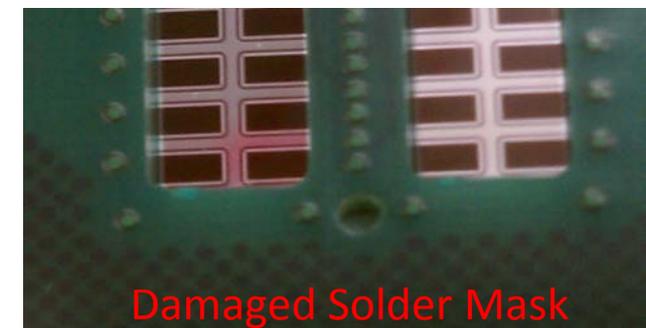
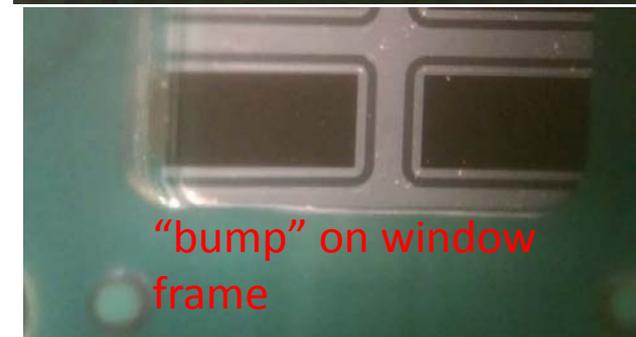
Silicone failures investigation

- Several showed water
 - Failures due to blocked carrier board hole
 - Blockage prevents water vapor removal
 - Water in “face volume” conducted HV to signal vias producing black gunk from circuit board and via material
- Several have evidence of mechanical interaction of window frame and optical connector

- Initial failures account for 40% of the attrition
 - 40% of initial failures reported as "snug"
 - Less precise prototype optical connectors may be the limit of usefulness of prototype detector.
- Initial failures should be replaced.
- Water failures (25%) due to blocked carrier board holes should be prevented
 - QA test checks for gas flow through hole now.
- Far higher fraction of "not in gas system" units failed over time
 - **Don't run APDs without gas system.**

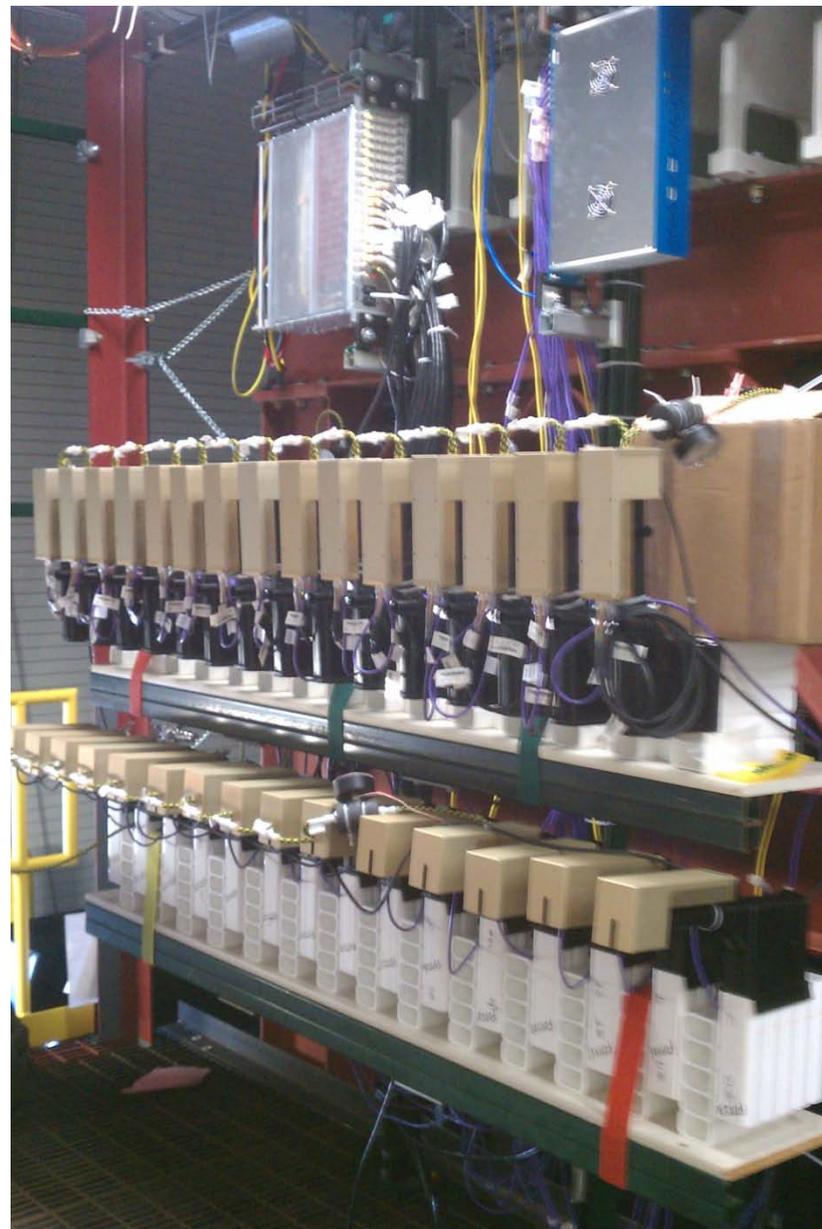
Final Installation test progress

- Mechanical parts have been assembled
- Plan for DAQ, power, water, and dry gas supplies in place
- Electronics and APD Parts shipped week of Nov 5
- Installation began week of Nov. 12
- **25 installed**
 - 800 pixels, ~2 bad PIXELS while running Warm (high dark current)**
 - One bad pixel and one bad Array running cold**

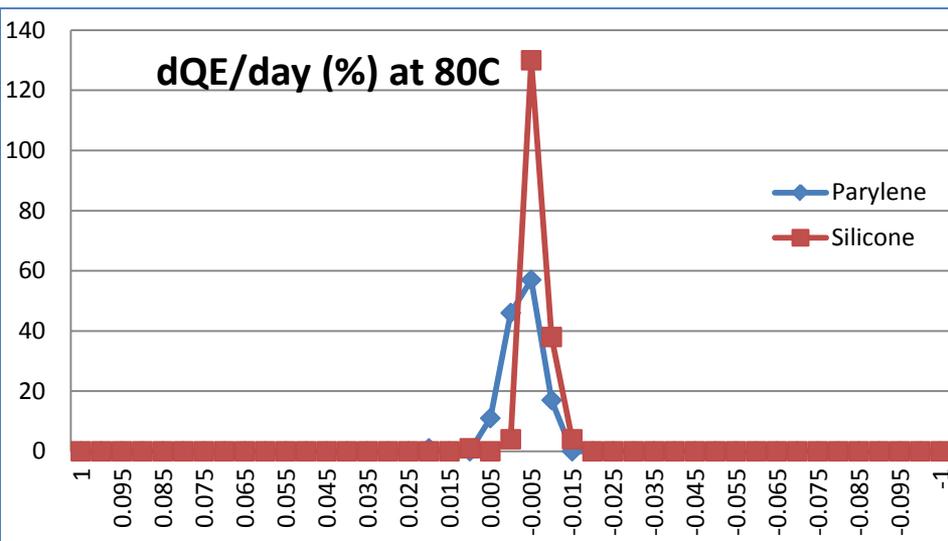
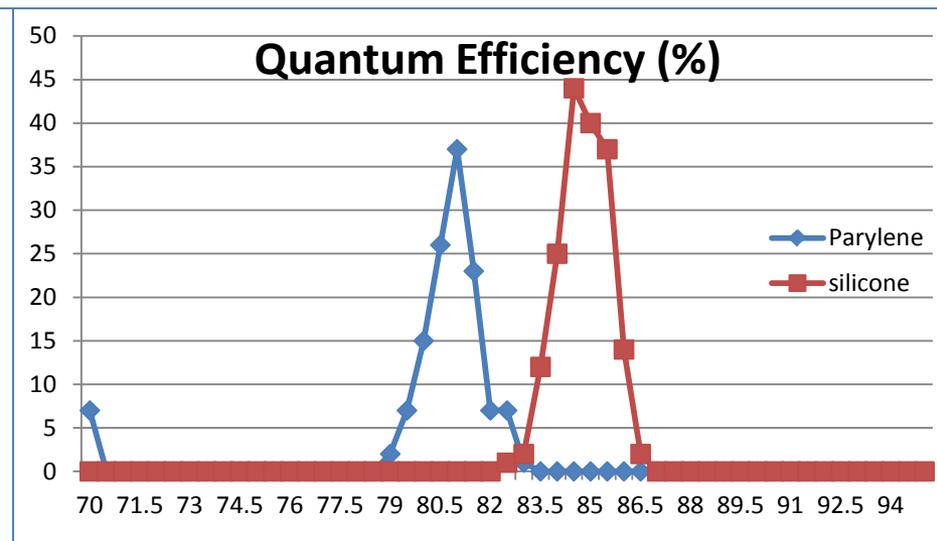
APD Coating tests

- Tests of aging of coatings at 80C for parylene and silicone coated APDs.
- 6 APDs of each type of coating
 - Chemical aging processes typically go 2 times as fast for every 10°C increase in temperature.
 - We have completed an 112 day test (as of 11/2/2012)
 - Relative to room temperature, this is approximately 20 years of storage
 - Relative to operating temperature of -15 C, this is 220 years of operation
 - Test with 523 nm light, about the middle of our spectrum
 - Average change was -0.005% /day for silicone, and 0 for parylene
 - Total change in 10years would be 0.025% change in QE for silicone and 0 for parylene
 - Also no visible evidence of discoloration or yellowing seen
 - Test continues
