Assembly Status

Patrick Lukens
Level 2 Manager for Assembly

Detector Assembly

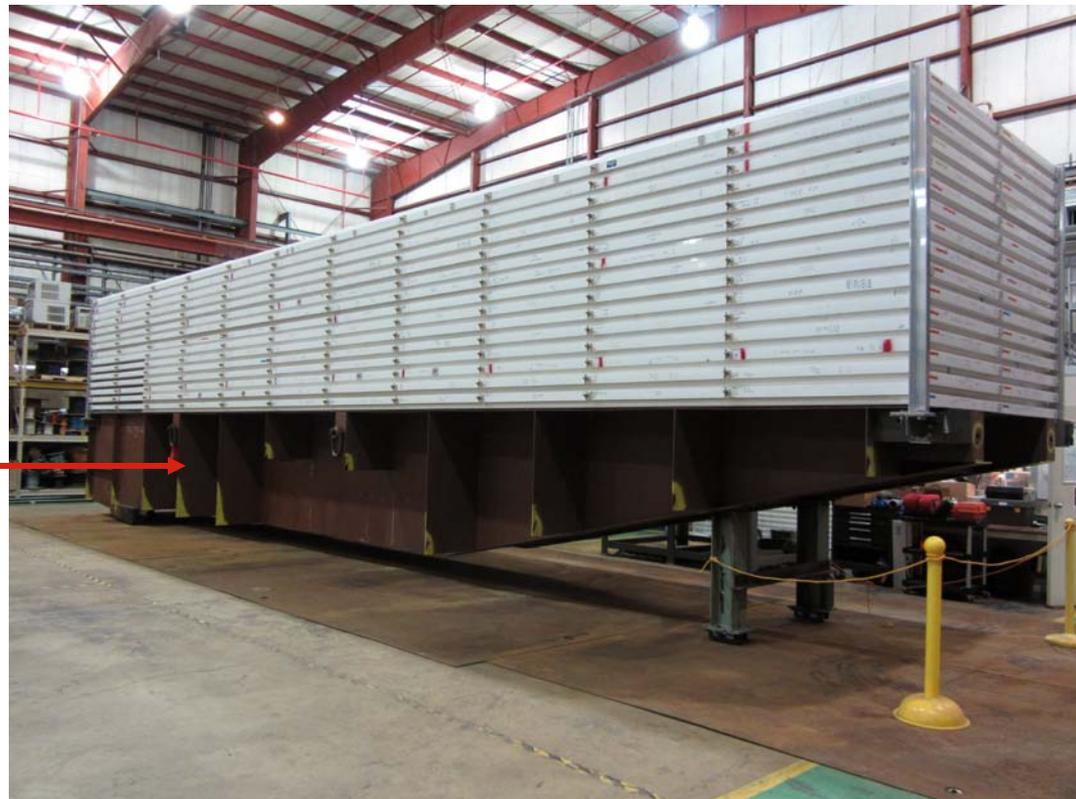
Full Height Engineering Prototype

Table top

FHEP

- FHEP was assembled at ANL in Aug-Oct. 2011
- Built and shipped on the pivoter tabletop

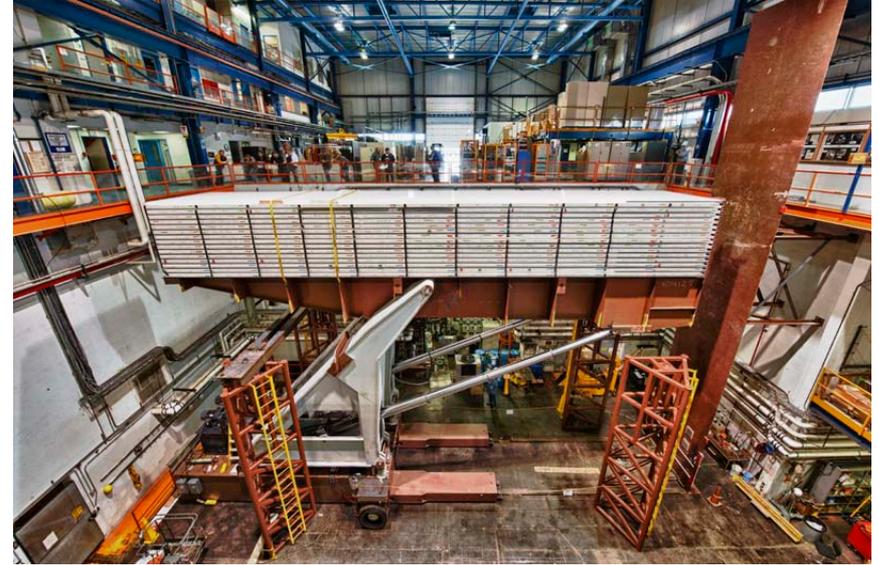
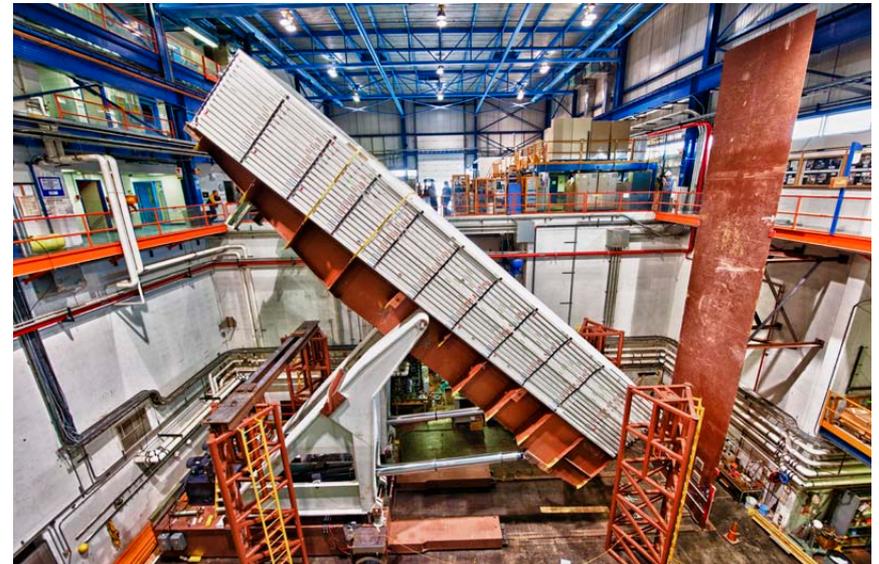
FHEP Installed at FNAL

- The FHEP was also a pivoter prototype exercise.
- Pivoter worked well
 - Prototype has many parts now considered to be spares for the production machine.
- Operation can be viewed
 - <http://www.youtube.com/watch?v=YtuMqjCiymQ>

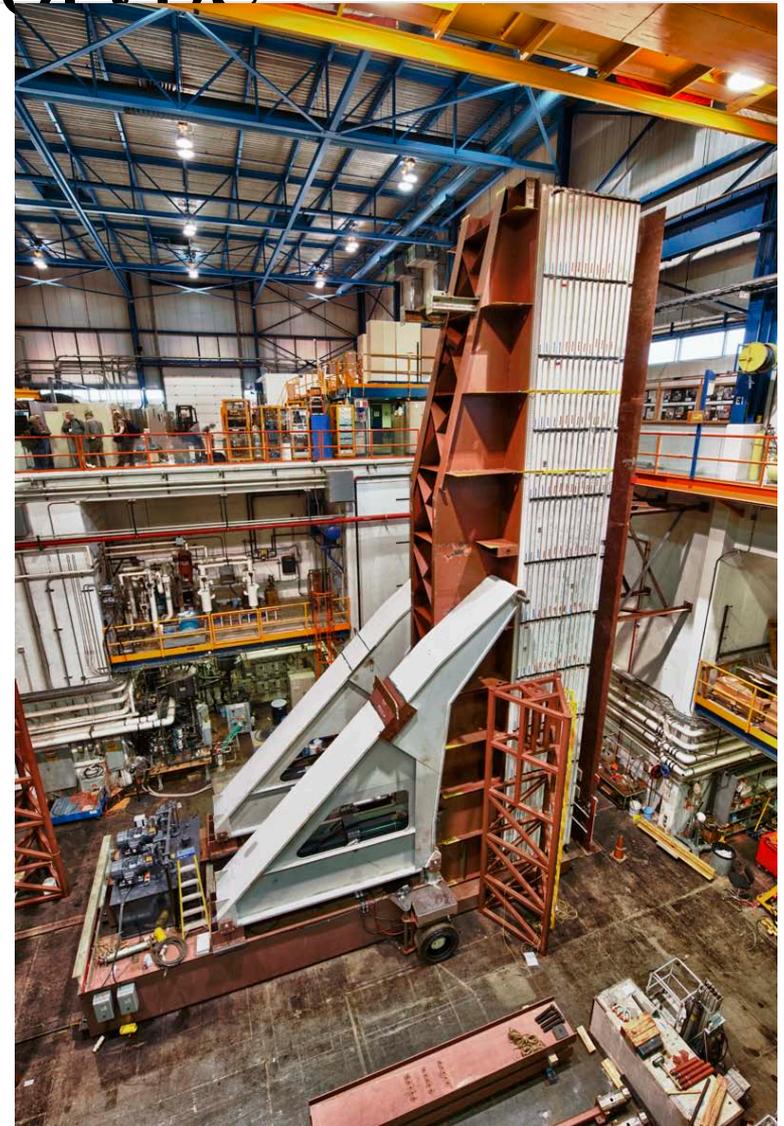
Far Detector Engineering Prototype

- FHEP was filled with water
 - Completed 12 Mar.
- The floor beneath it is bone dry
- Subtler details
 - Deformations
 - Strain measurements
- These will be studied when the pivoter is operational

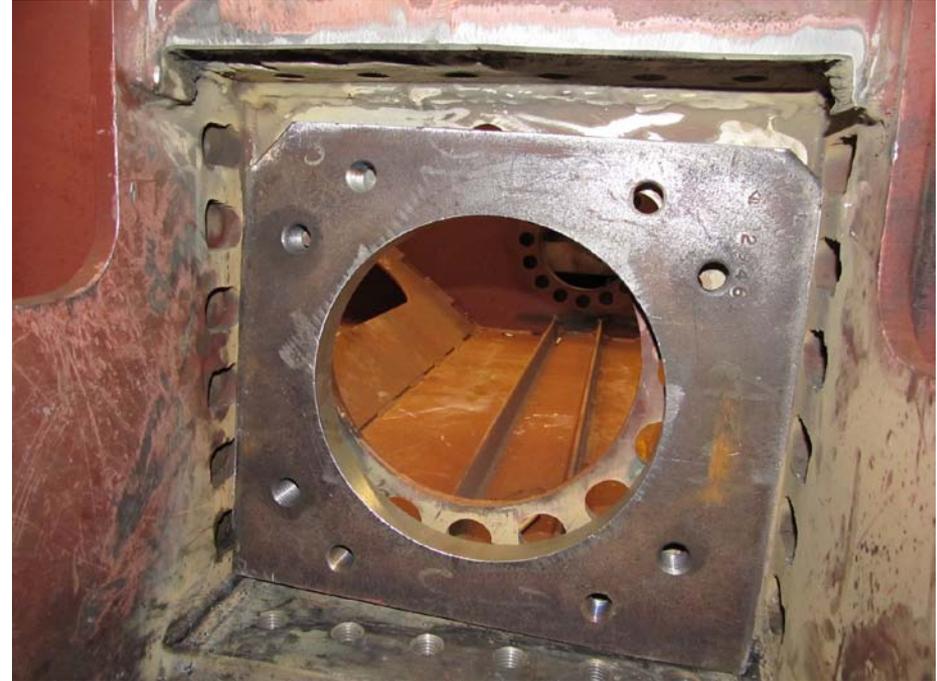
Block Pivoter Developments

- Table sections were shipped back to FNAL
- Parts were replaced and installed
- Back at Ash River 8 days later.
 - We lost the month of February for this.

- The table top delivery, expected in Nov. stretched out until mid Feb.
- Assembly of the parts in hand proceeded as well as possible.
- However, on Feb. 1, a design flaw turned up in the pivoting sections
 - Parts had to be modified
 - Sent to a local machine shop, and they were ruined.

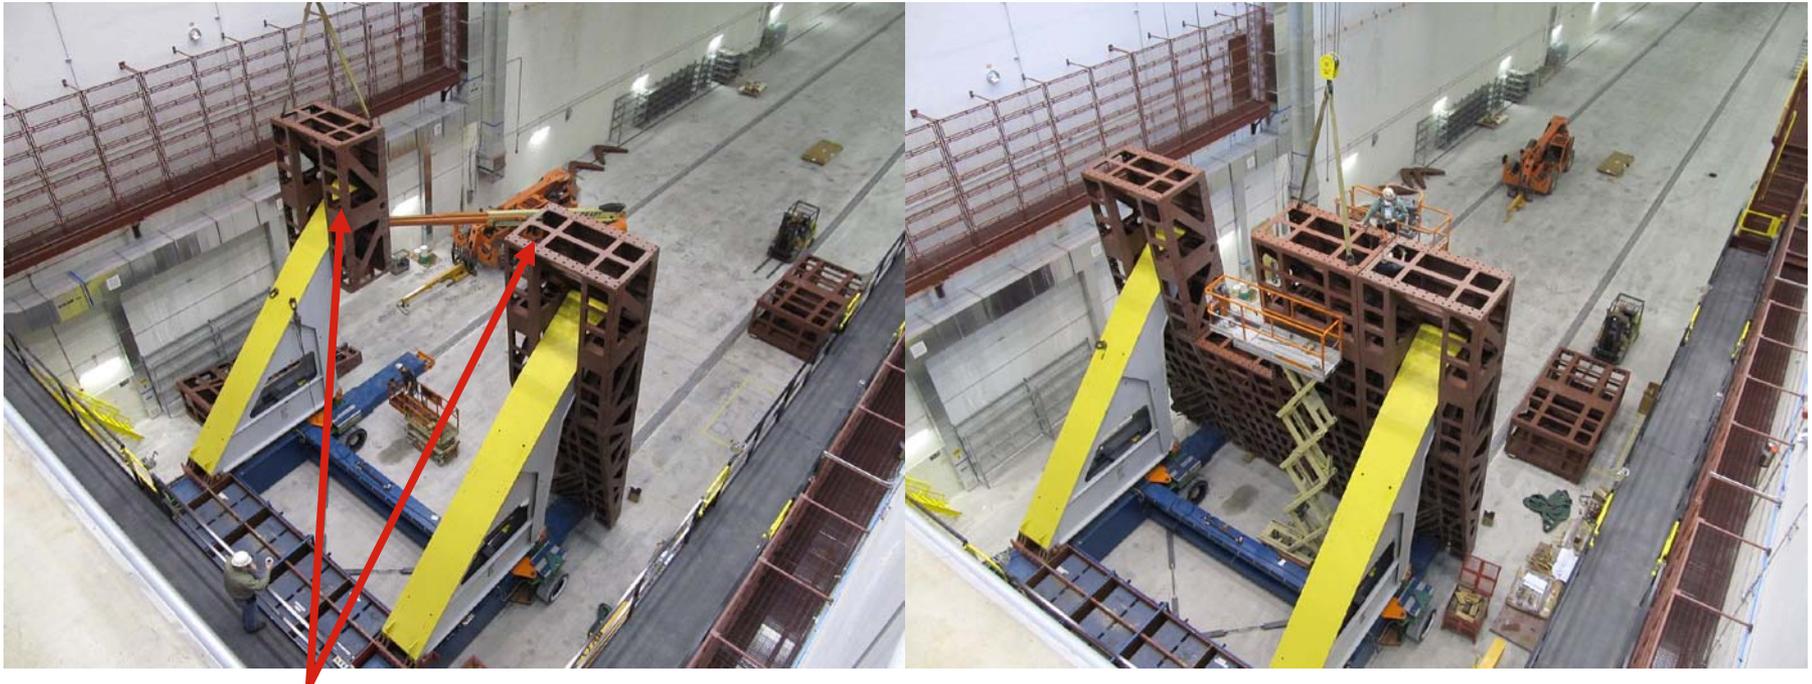
Repaired "A" sections

- Pivoter assembly resumed immediately
 - 6 March

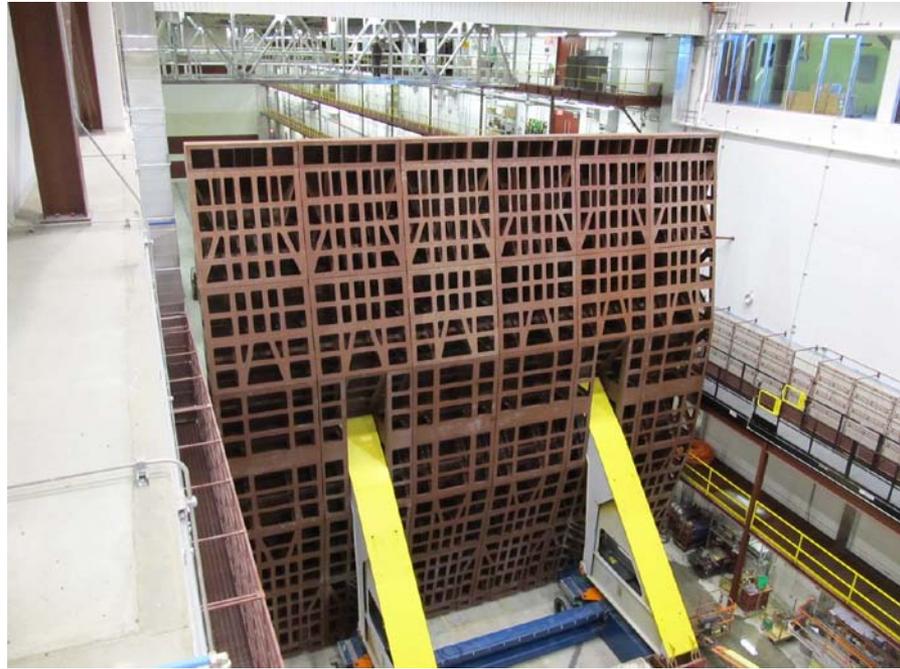
- By 23 March, all sections had been installed
- All 3300 bolts are torqued to specification.

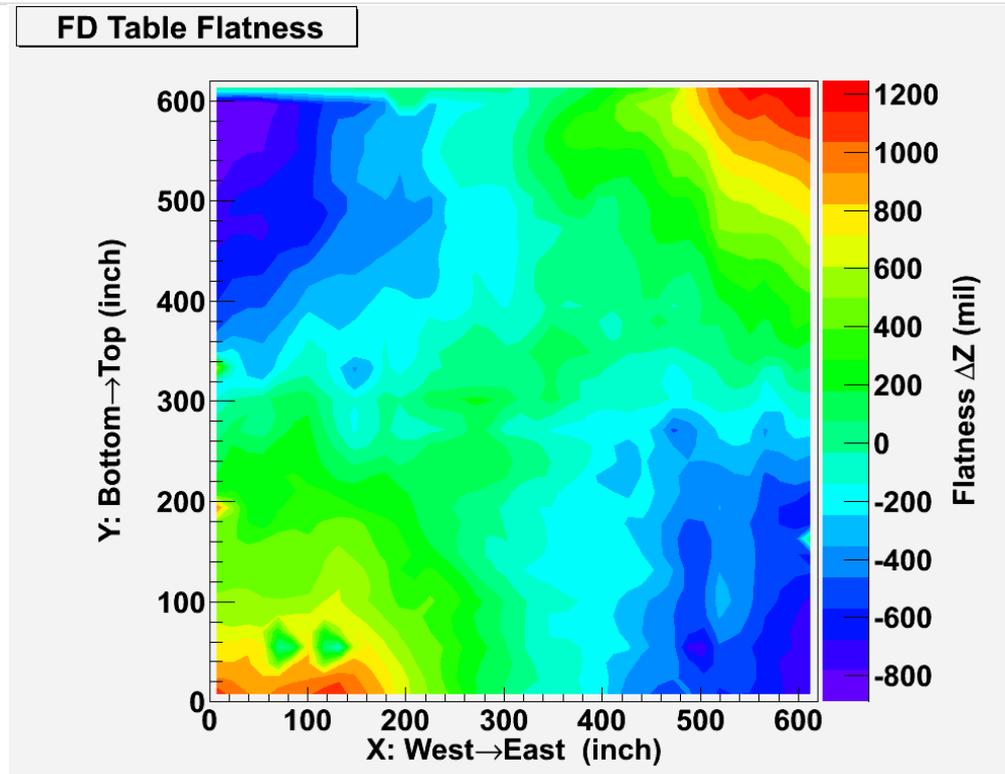
Pivoter Survey

- A first survey of the pivoter was performed 26 Mar.
- It indicates a saddle shape, ± 1 inch

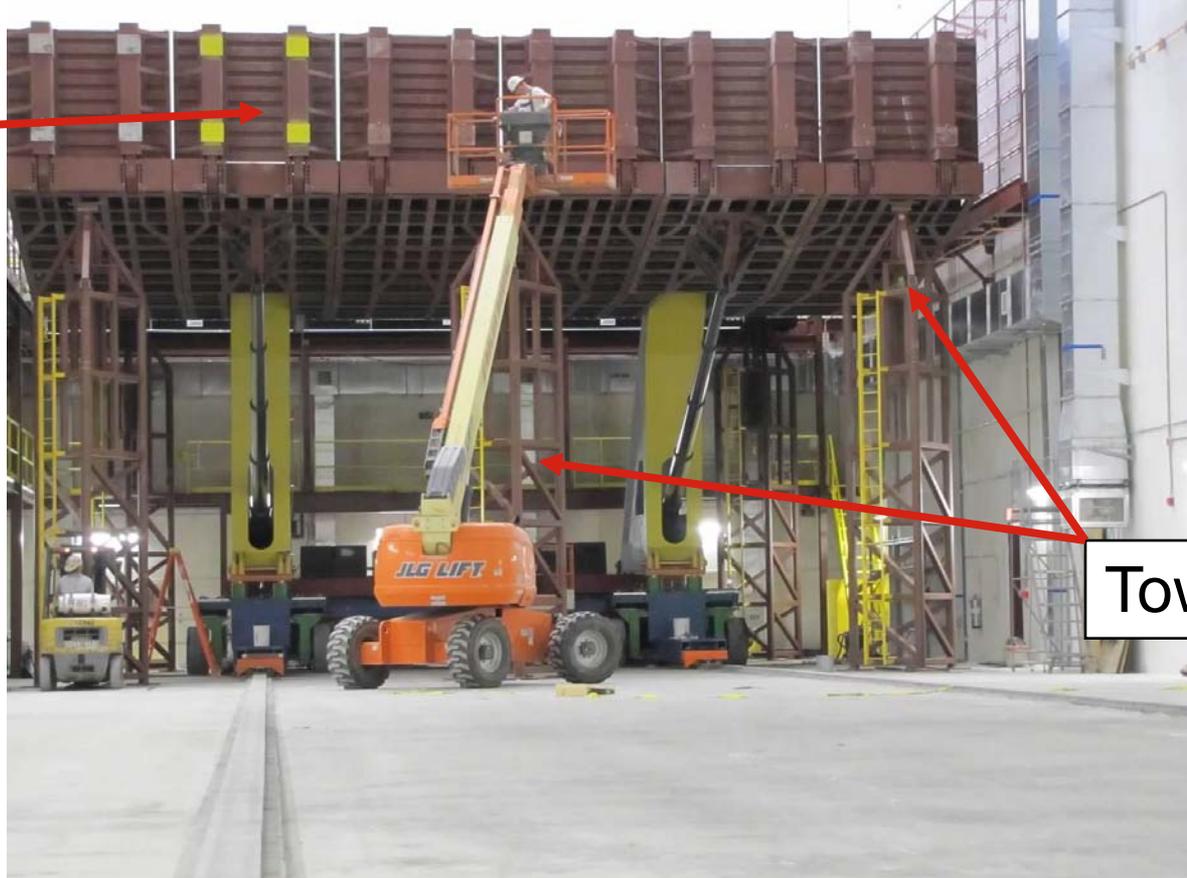
Pallets

Towers

- Towers have been installed
 - These take the table load when horizontal, hydraulics deenergized.

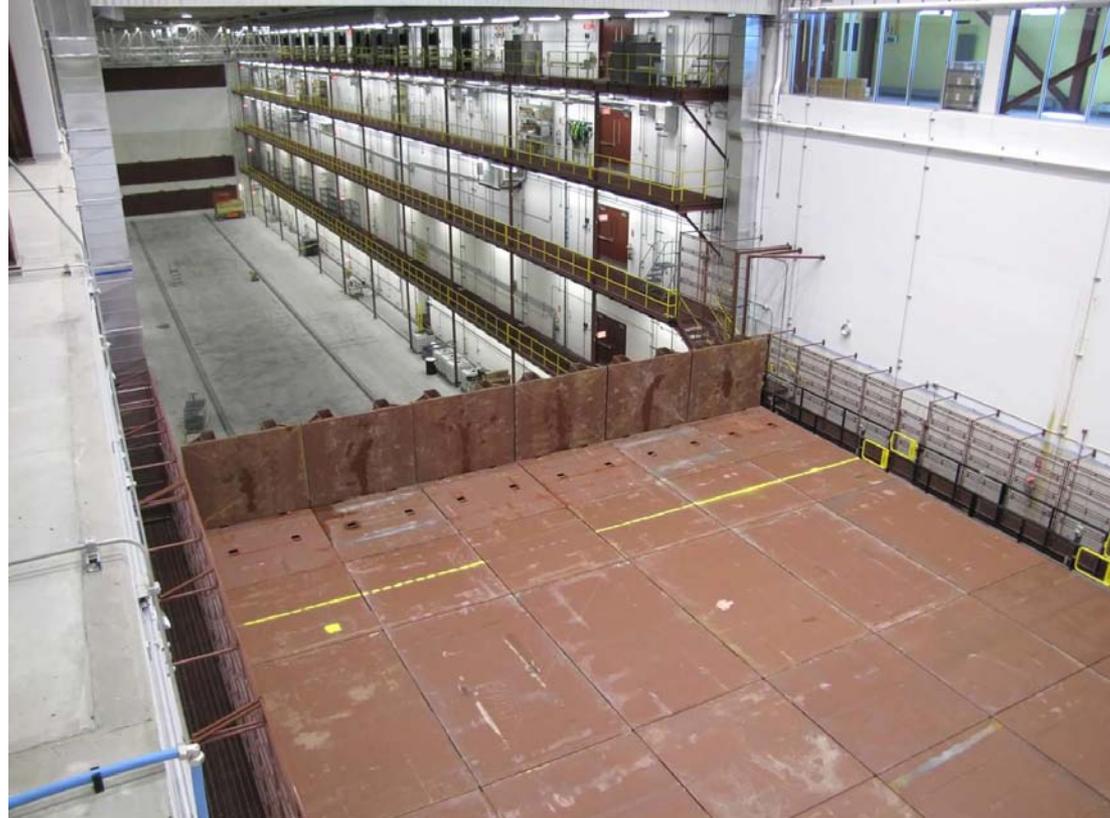
- Survey in the horizontal position this week.
 - Decisions about shimming the surface will follow.

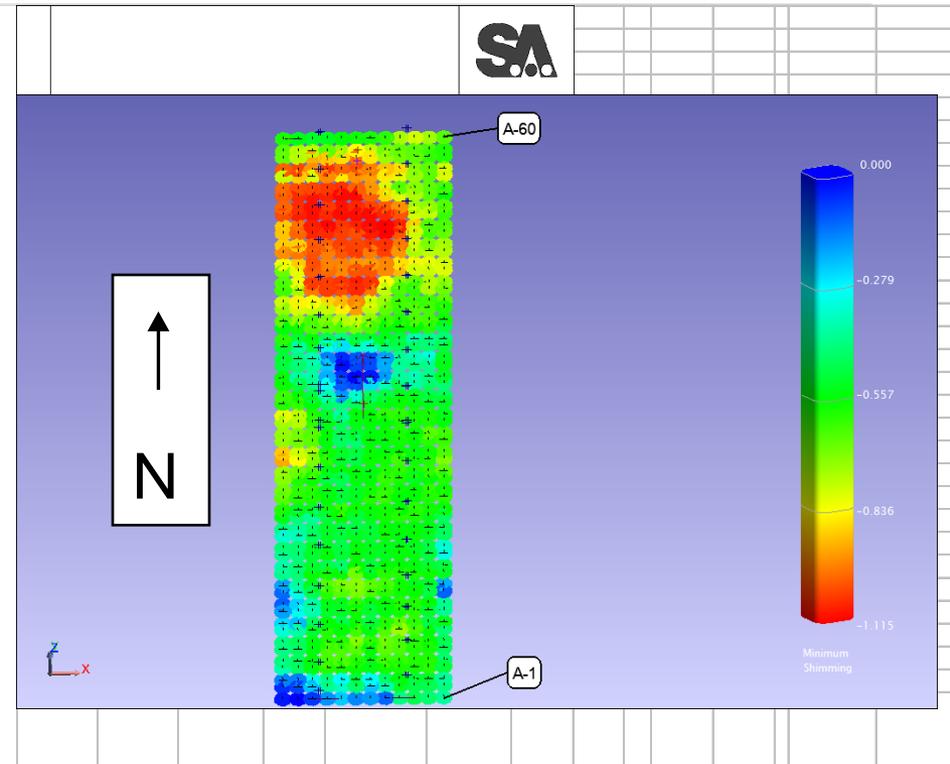
Floor Survey

- The floor flatness was surveyed 26 Mar.
- Important, to ensure uniform loading on the 24 pallet feet.
- Shims will be placed under each foot to compensate for unevenness.

- Blue = 0
- Red = 1 inch low

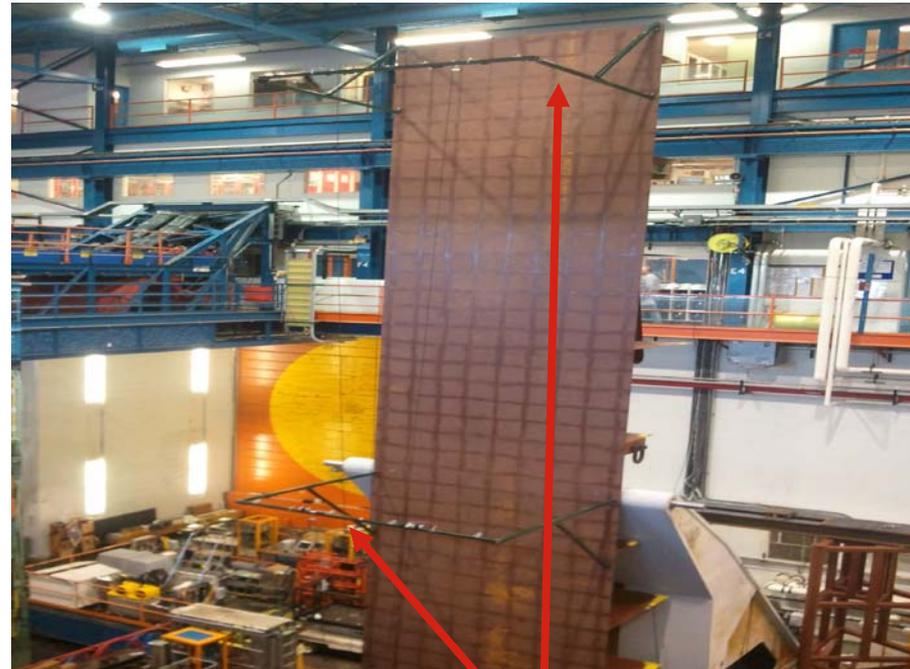
- We plan a “Pseudo-block” exercise as soon as the pivoter is fully operational
 - Similar one was done on the prototype
 - Define block volume with something simple.
 - Test clearances and positioning against the south wall.

Unistrut mockups on the prototype table

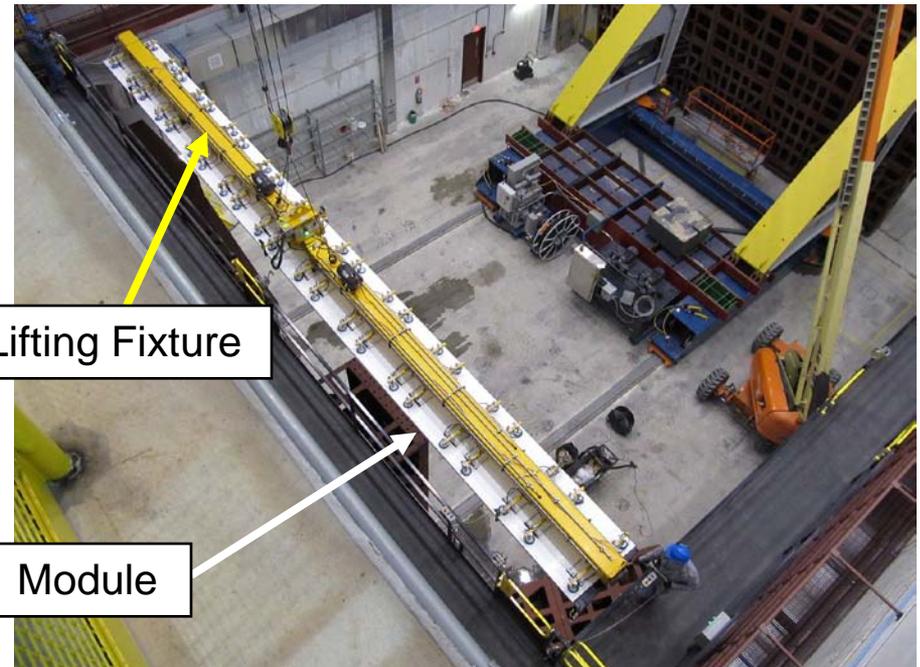
- Three lifting fixtures are being assembled.
- Two are at Ash river and is ready for assembly
 - Sufficient for assembly to begin
- The third is a spare, still at ANL

Lowering a module

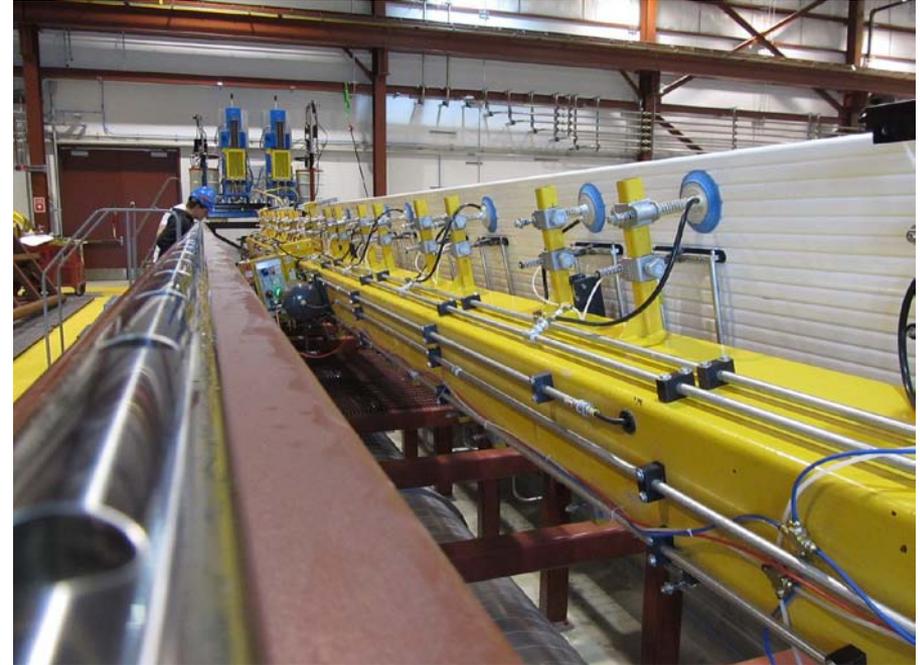
- The adhesive dispenser has been in place for a couple of months
- Pumps and drive motors have been commissioned
- Module rotation working
- Prototype assembly can be viewed:
 - <http://www.youtube.com/watch?v=4bNwHizbWkM>

- Module being rotated within the dispenser

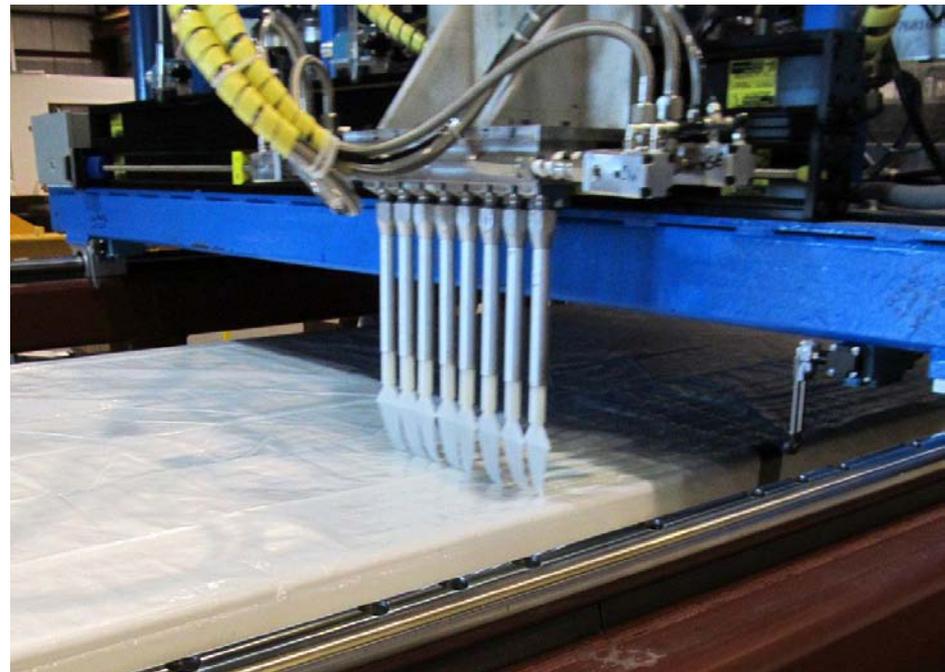
- Vapor level tests were performed week of 26 Mar.
 - UM Ind. Hygiene in attendance
 - MMA and %LEL measurements were taken
- Results were same as tests at ANL
 - %LEL barely measureable
 - No special fire response is needed.
 - MMA levels at 1-2 ppm
 - 50 is our threshold

- Adhesive dispensing
 - 8 simultaneous beads
 - 4 passes per module

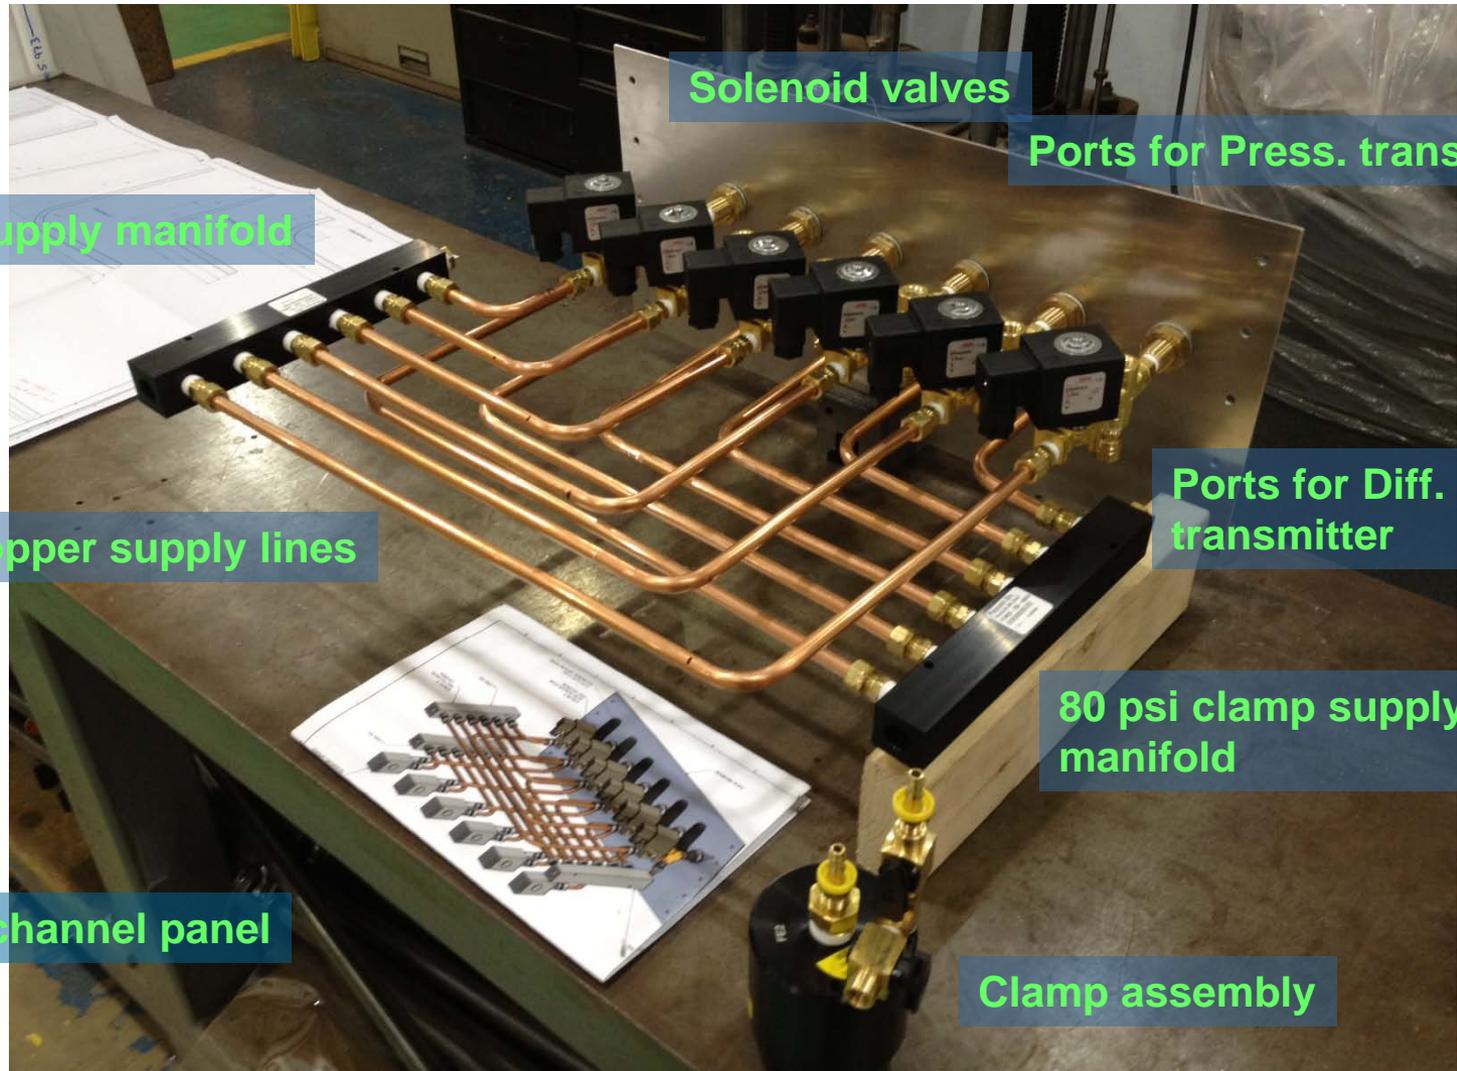
Leak Tester 6 Channel Subassembly

Solenoid valves

Ports for Press. transmitter

Module supply manifold

Copper supply lines

Ports for Diff. Press. transmitter

80 psi clamp supply manifold

6-channel panel

Clamp assembly

- Modules will be tested for leaks when they arrive
 - Looking for shipping damage
- Compressed air will be used
 - Plan for low pressure, 1.5 psi
- Tester is being designed and built at ANL
 - Commercial parts, gauges, software.
- Last parts arrived last week
 - Delivery to Ash River is planned for 19 April.

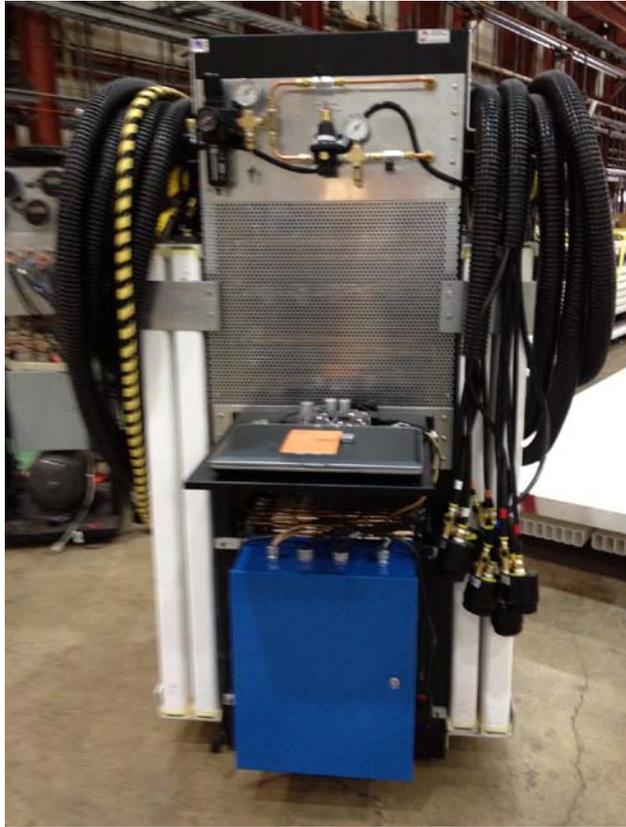
- Operator end

30 Channel Leak Tester

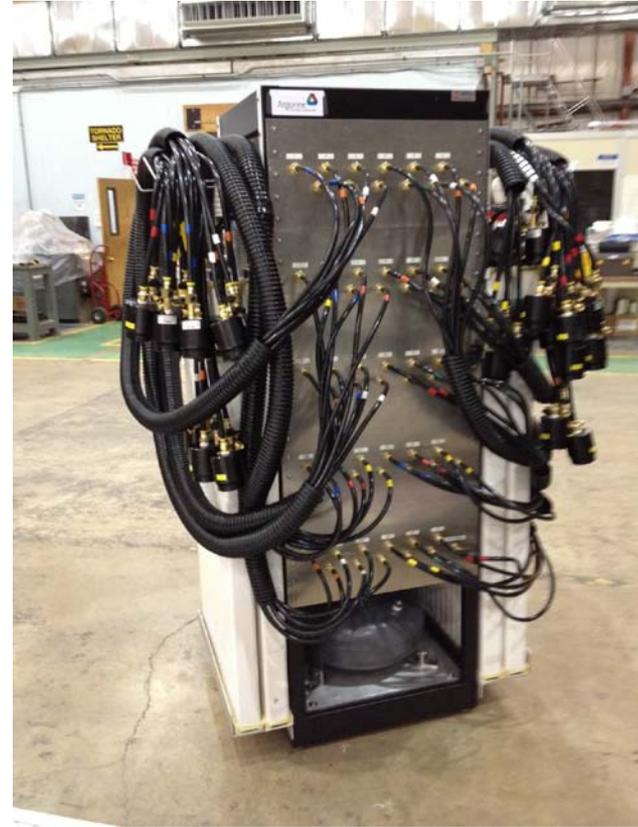
- Business end
