Assembly Report

Patrick Lukens

Fermilab

Detector Assembly

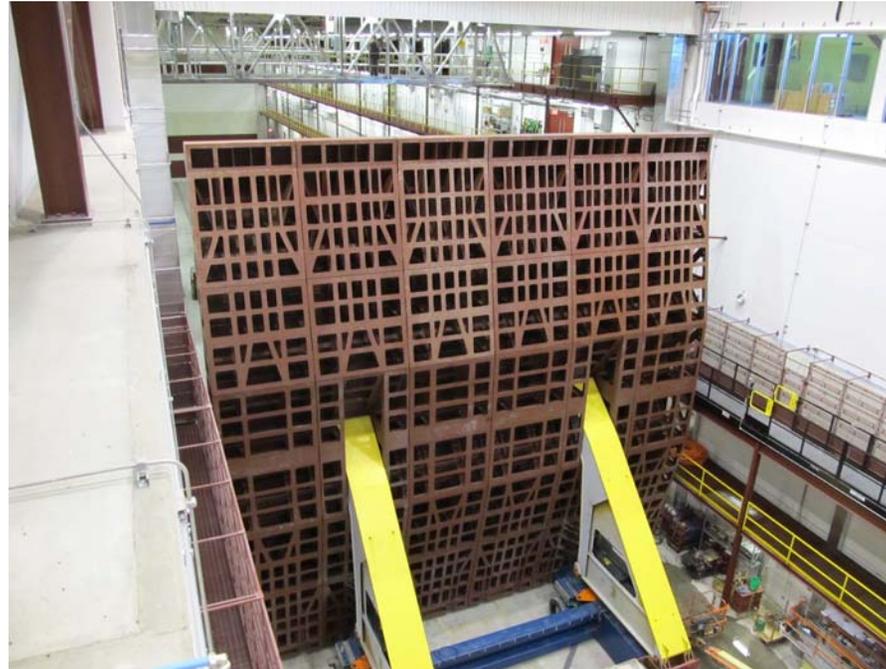
Block Pivoter Developments

- Block pivoter was assembled by 1 April.
 - Small, additional issues were resolved in May- June
 - Fall protection, pivot reinforcement, alignment structure

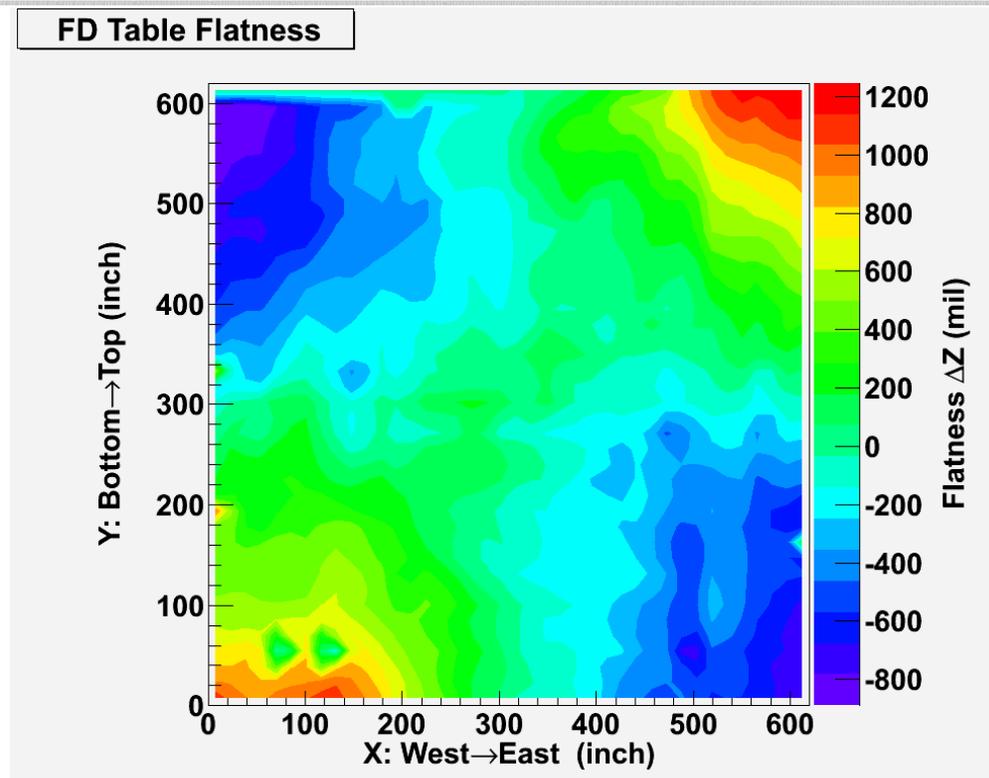
Pivoter Survey

- A first survey of the pivoter was performed 26 Mar.
- It indicates a saddle shape, ± 1 inch

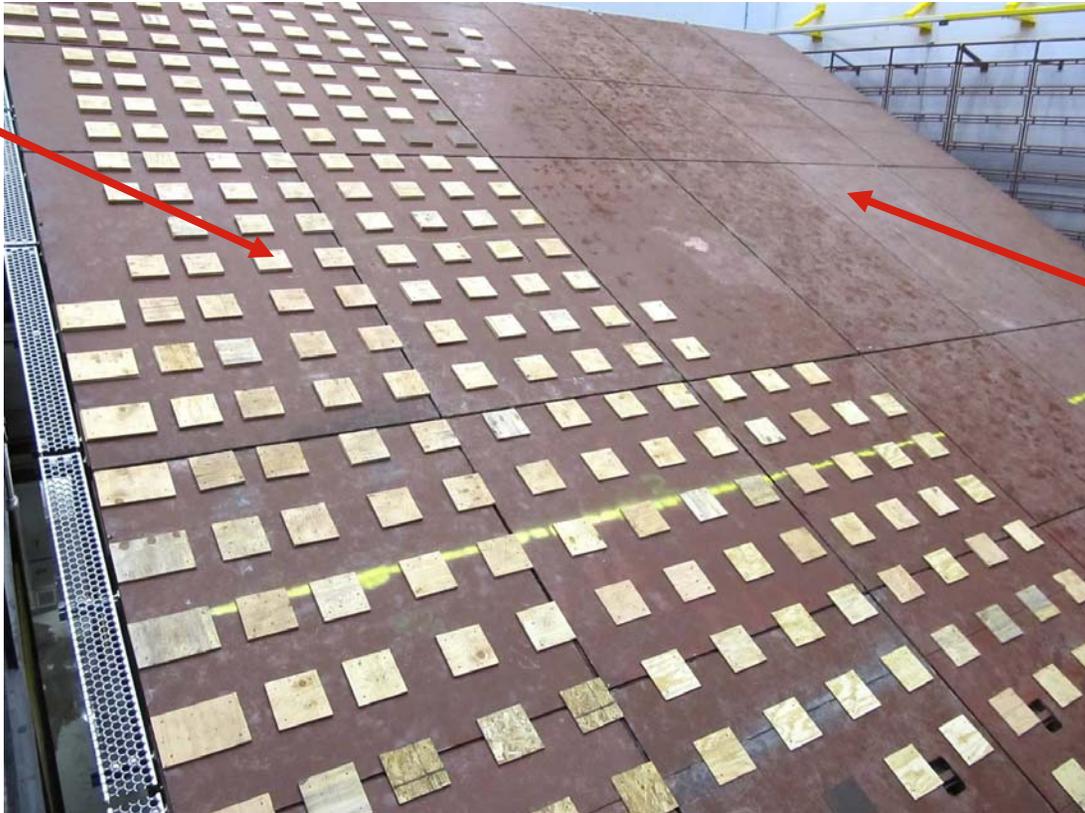
Wooden
Shims

Steel
Surface

- The table surface was shimmed, based on the flatness survey

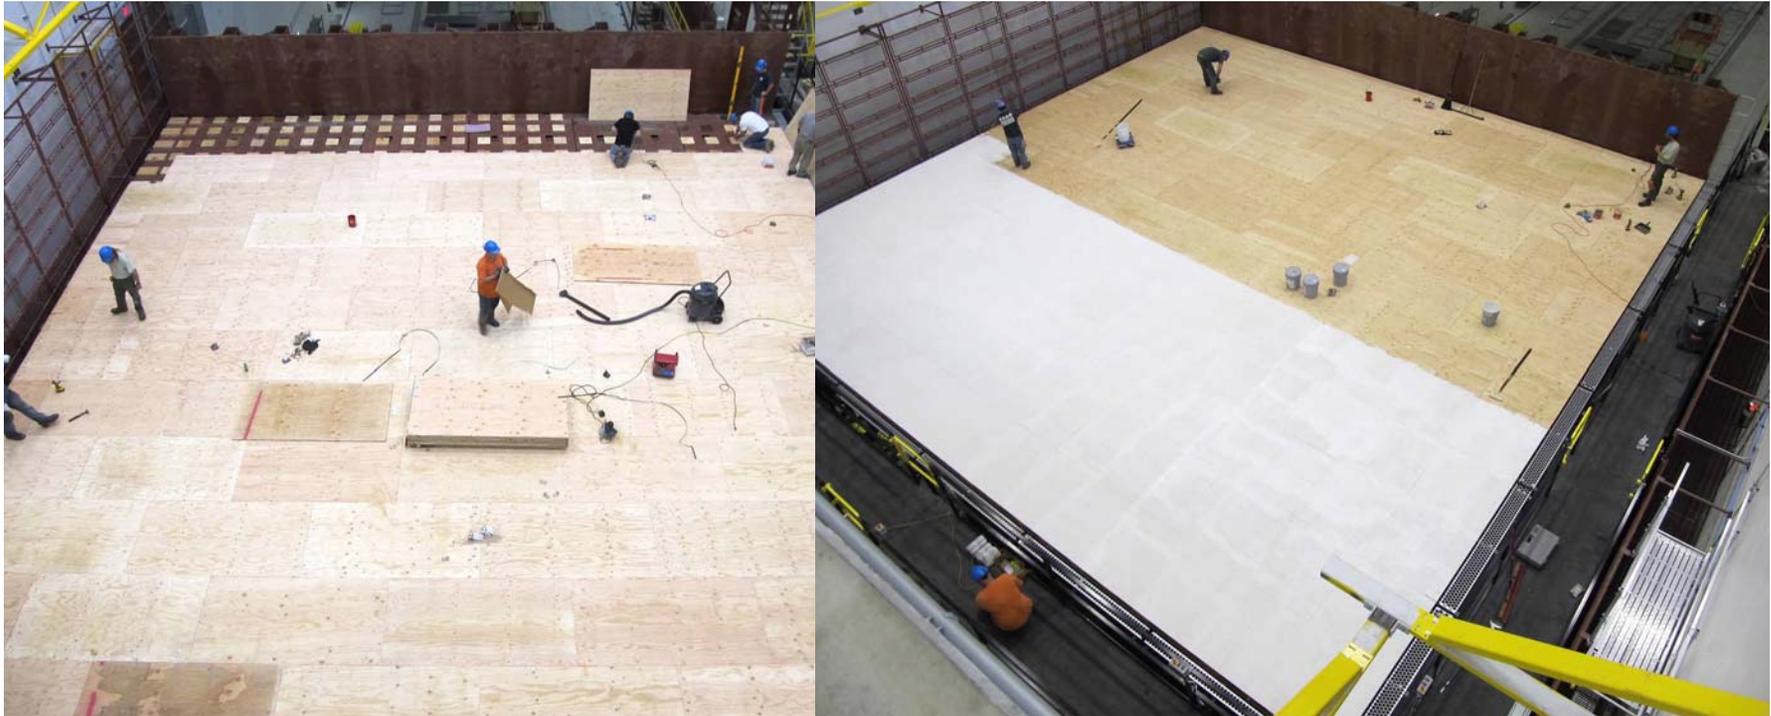
Working surface

- The shims were then covered with plywood and the surface painted.
 - Shimming of the pallet positions was then needed as well.

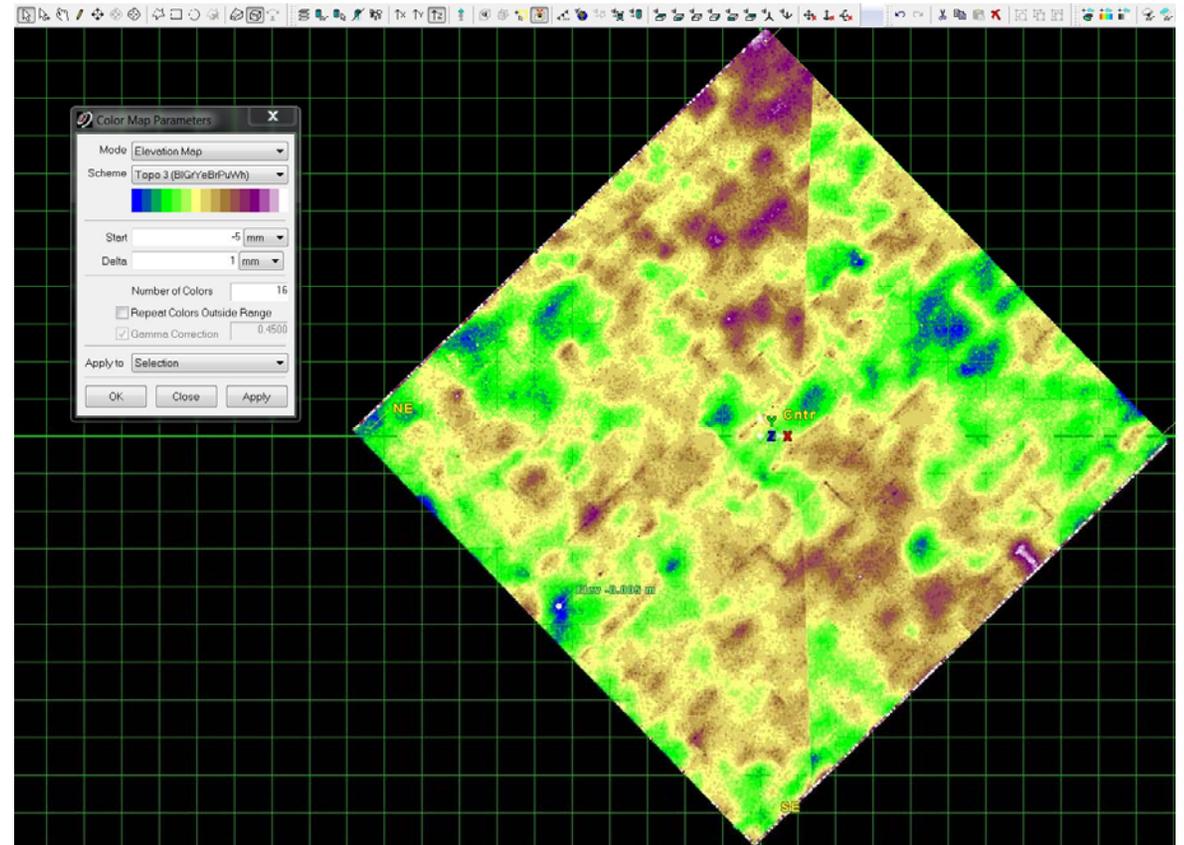
Table Top Survey after Shims

- Full range is now ± 8 mm (spec. is ± 1 cm)
- Measurement taken with the ceiling-mounted laser scanner
 - Part of our QA

- ~ 2 mm discontinuity due to survey artifact

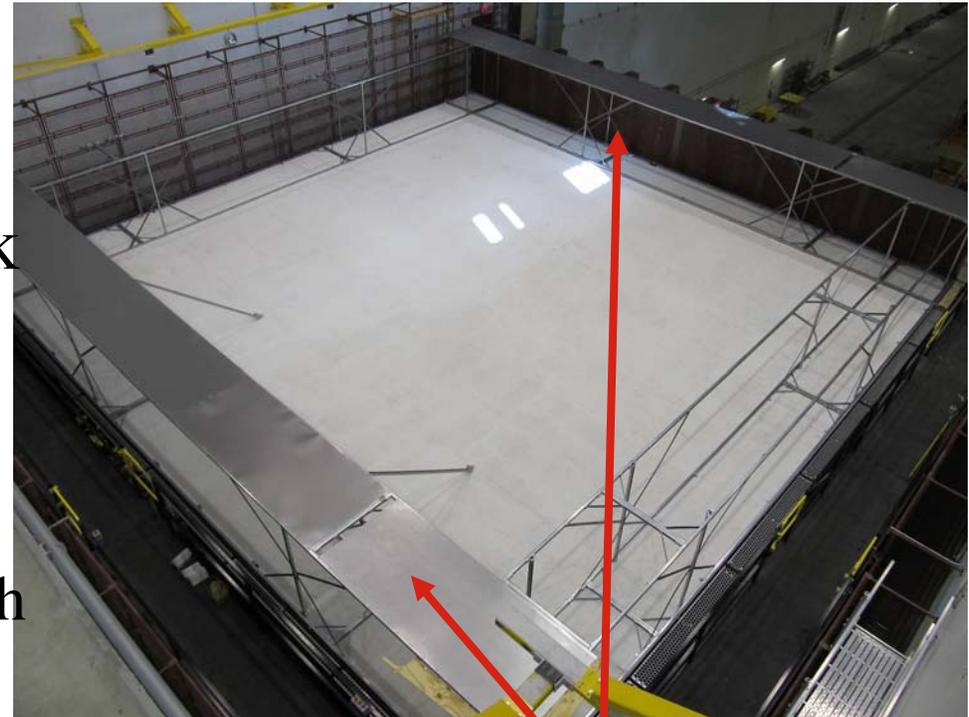
- We held a “Pseudo-block” exercise the week of 4 June
 - Similar one was done on the prototype
 - Define block volume with something simple.
 - Test clearances and positioning against the south wall.

Unistrut mockups on the table

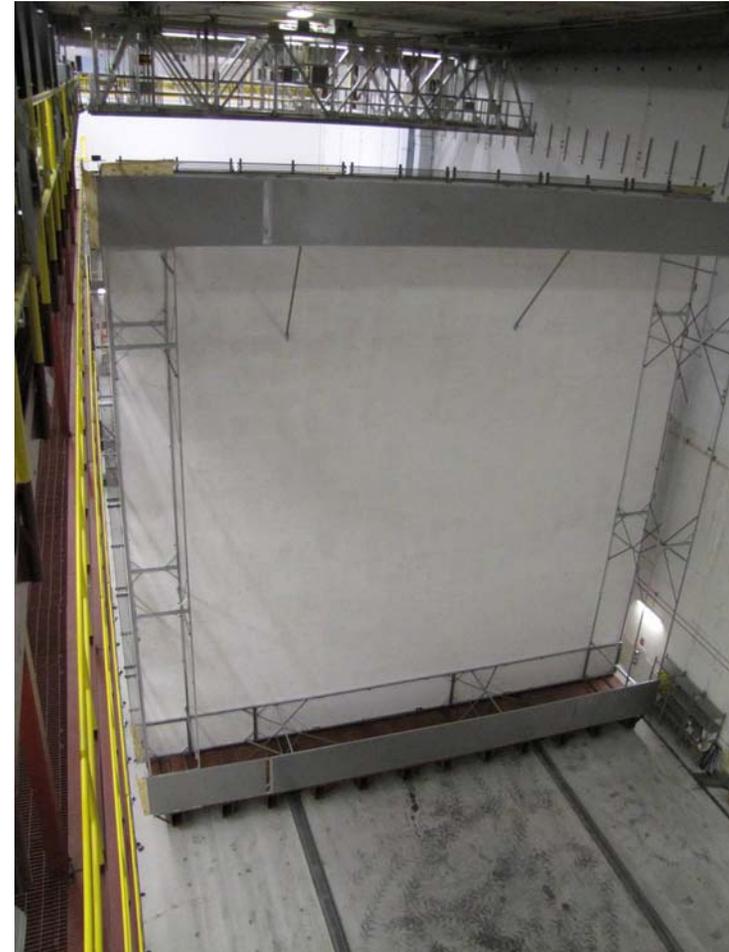
- The table top, with “mock block” was rotated to vertical
- Then traveled to the south end of the hall
- Clearances checked to catwalks
 - West – 6”
 - East assembly area – 2”
 - Judged to be fine.

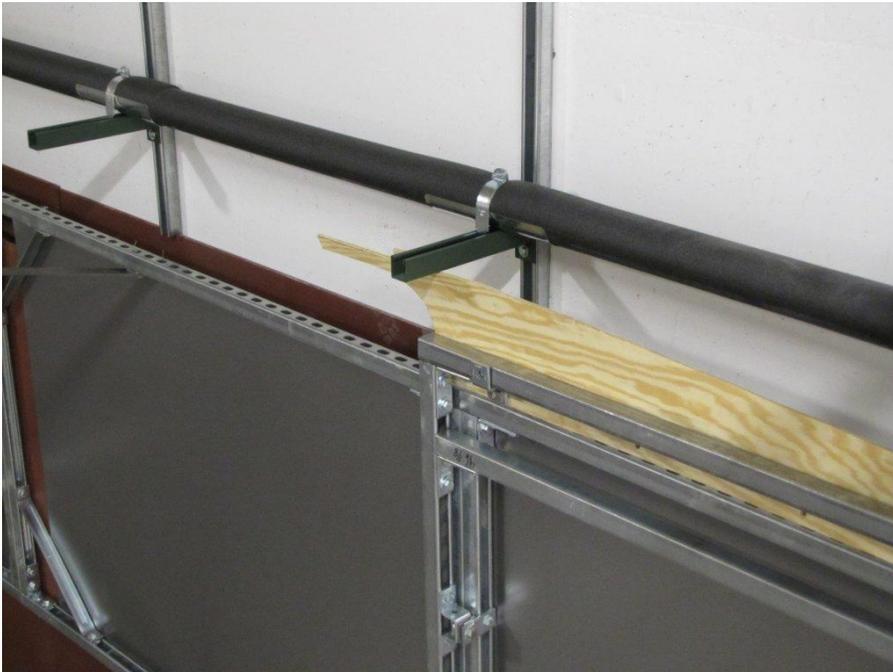
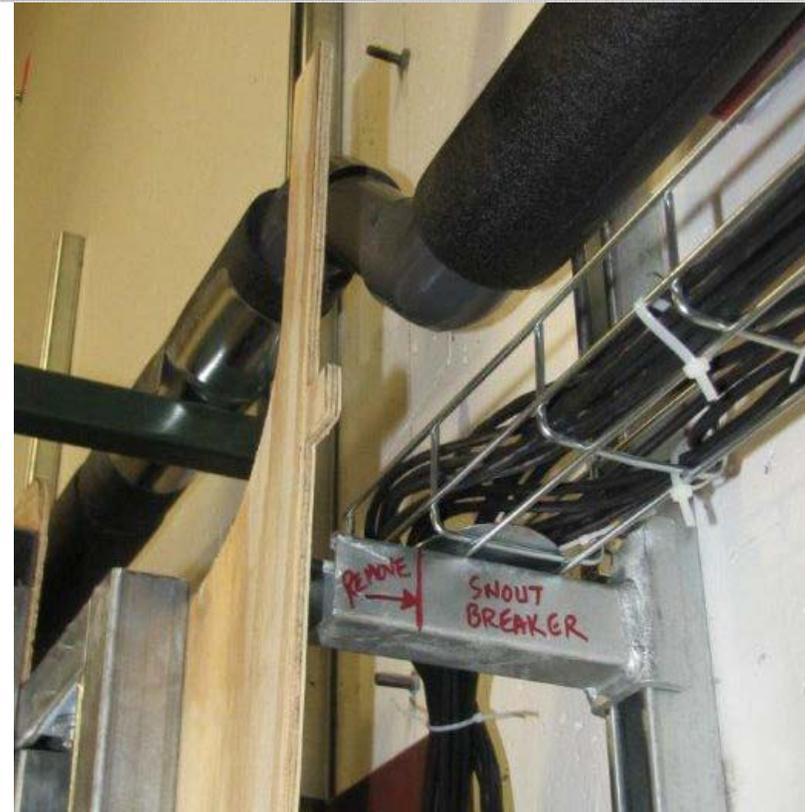
- The plywood optical connectors did their job on the south wall
 - Interferences with piping, cable trays is now fixed

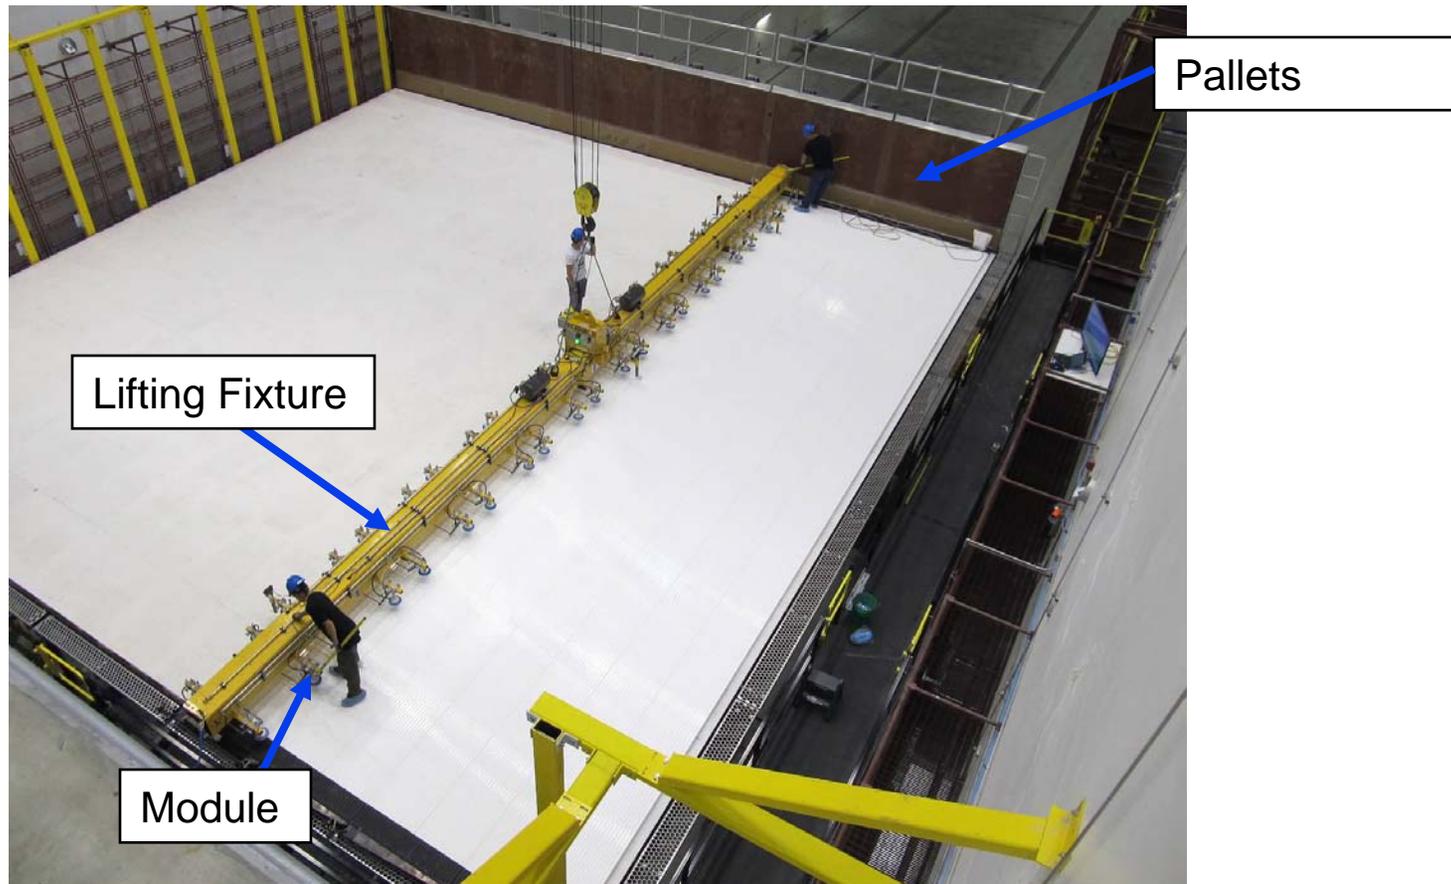
- Two lifting fixtures are at Ash river
 - The third is a spare

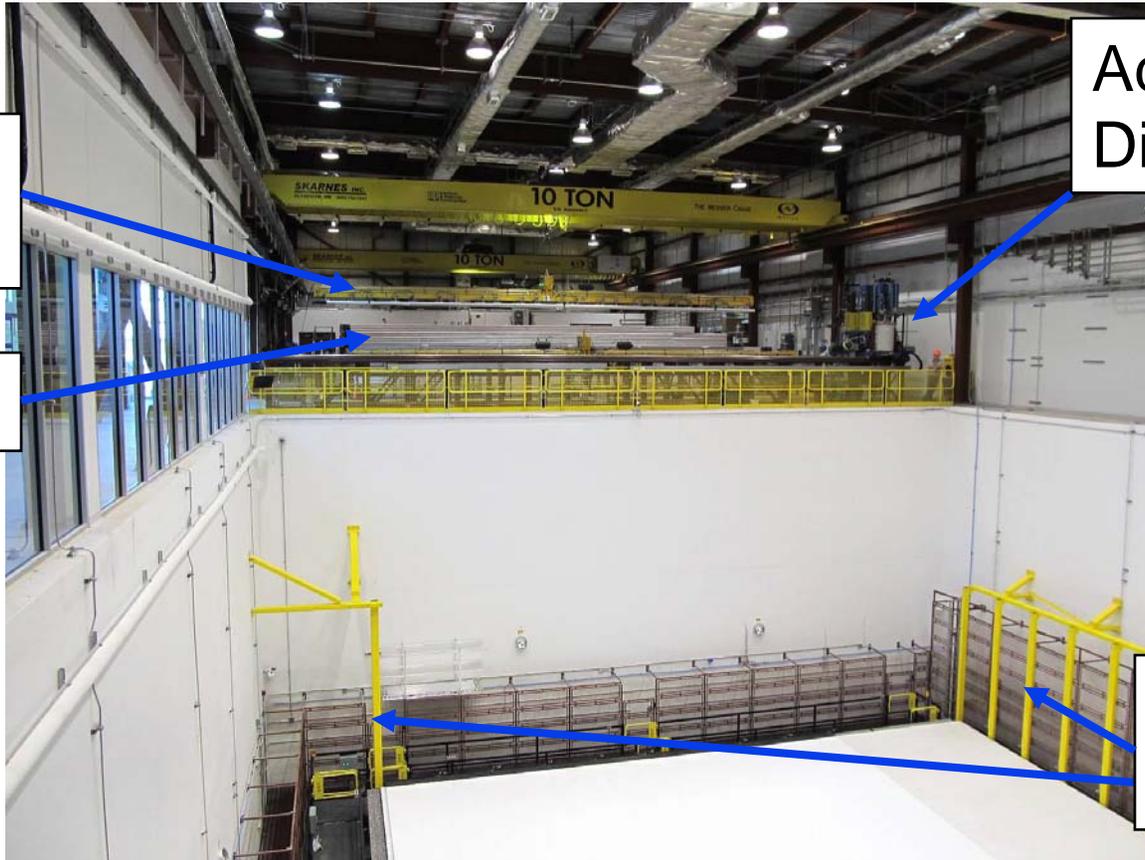
Assembly Area

Lifting
Fixture

Modules

Adhesive
Dispenser

Alignment
Poles

- Assembly area, viewed from the south

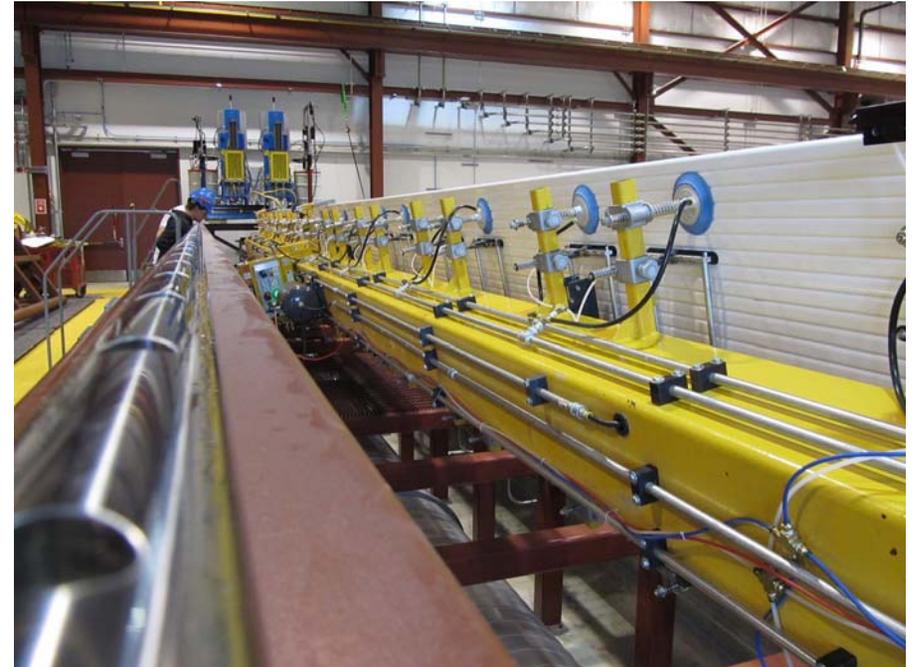
- The adhesive dispenser has been in place since Oct. 2011
- Pumps and drive motors have been commissioned
- Module rotation working

- Module being rotated within the dispenser

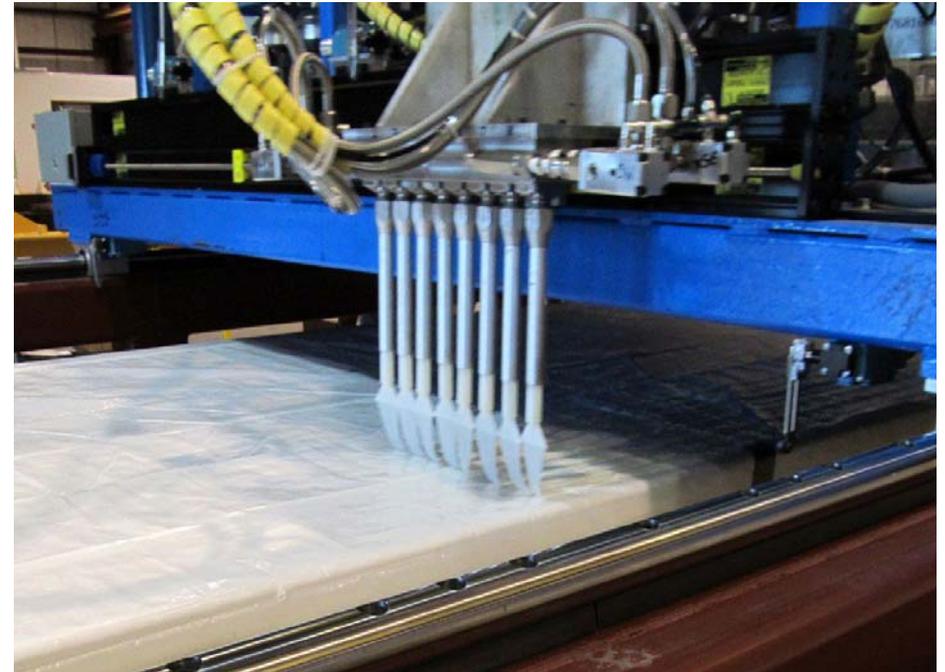
- Vapor level tests were performed week of 26 Mar.
 - UM Ind. Hygiene in attendance
 - MMA and %LEL measurements were taken
- Results were same as tests at ANL
 - %LEL barely measureable
 - No special fire response is needed.
 - MMA levels at 1-2 ppm
 - 50 is our threshold
- Adhesive dispensing
 - 8 simultaneous beads
 - 4 passes per module

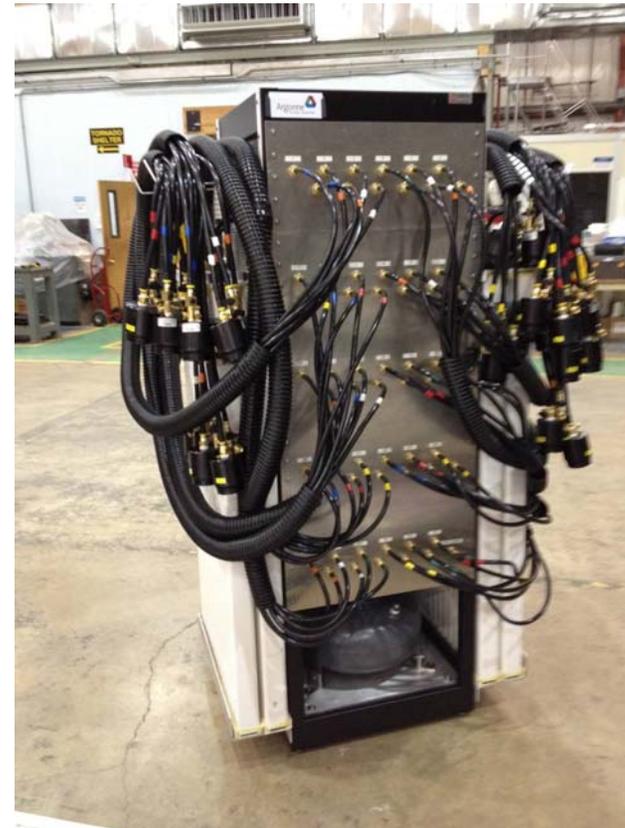
- Modules will be tested for leaks when they arrive
 - Looking for shipping damage
- Compressed air will be used
 - Low pressure, 1.5 psi

- 30 channel module leak tester

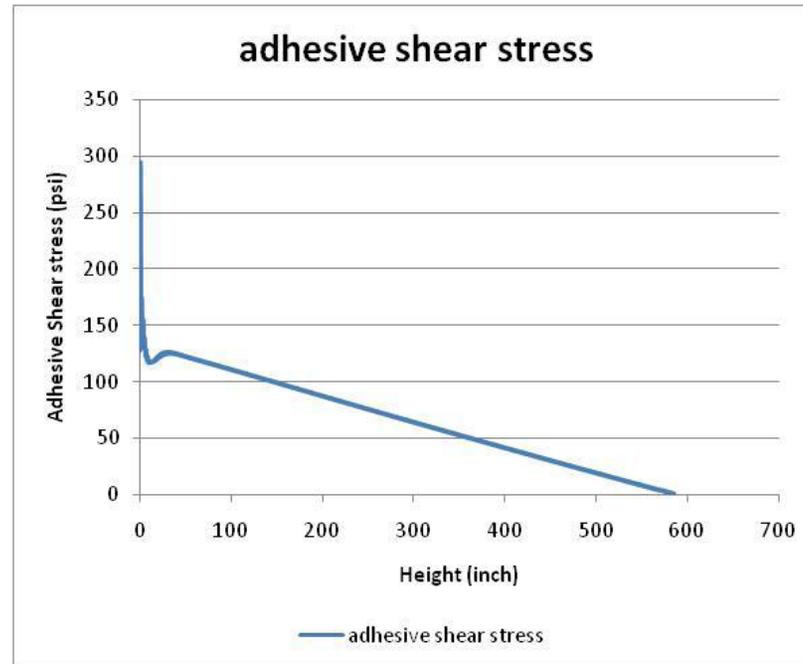
From Nova #5726

- Predicted maximum stress in the adhesive is 125 psi
 - Declines with height
 - Based on conservative assumptions about the PVC strength
- Our 500 psi standard is based on desiring a safety factor of 4 in this stress.
 - A standard that varies with position could give the same safety factor.

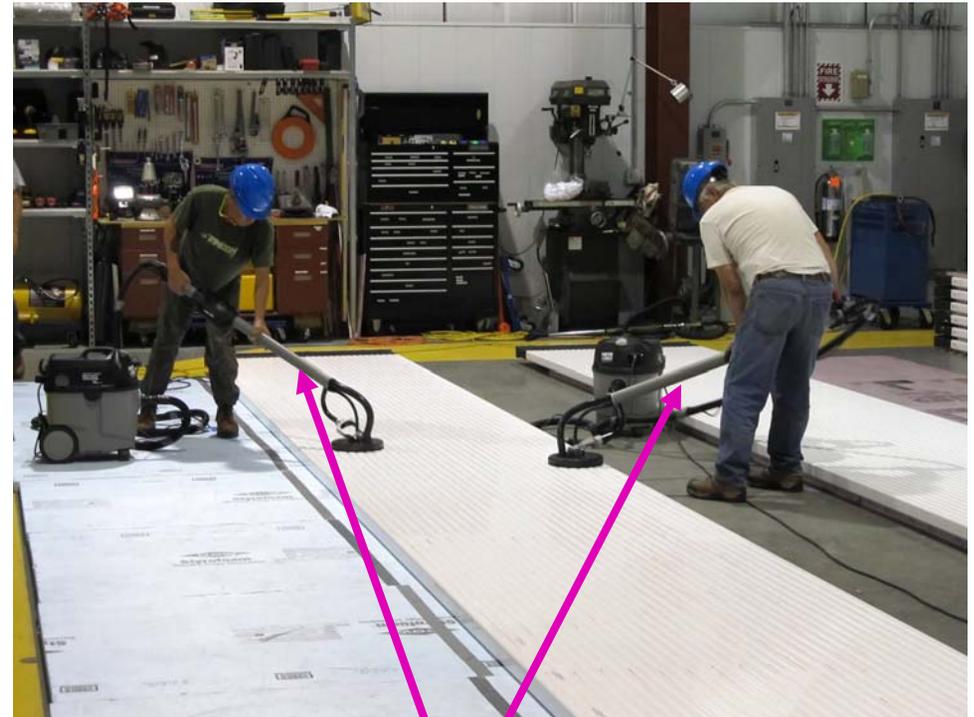
- Longer term, tests and technique development will continue.
 - Plan to avoid alcohol
- At the least, we will limit the areas of surface treatment.
 - Currently, about 1.5 hours/module for prep.

Drywall Sanders with Scotch Brite Pads

- Our short term plan is treat all glued surfaces the same
 - Scuff with Scotch Brite, avoid alcohol entirely
 - Replace our adhesive with ZH52-6
