APD Status

Leon Mualem

APD Status/Plans

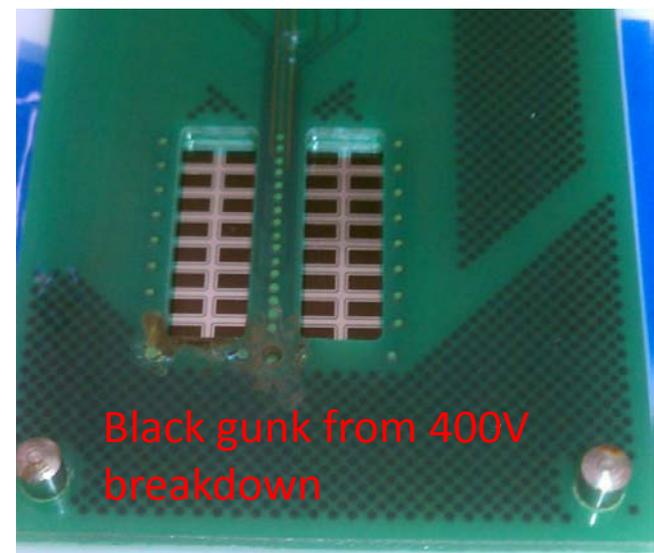
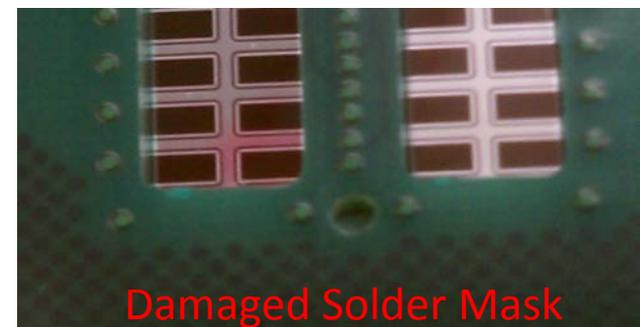
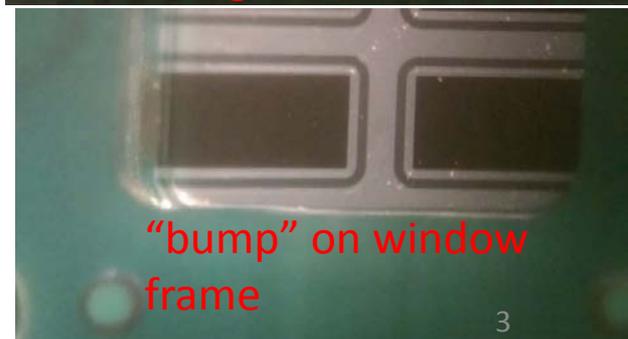
Silicone failures investigation

- Several showed water
 - Failures due to blocked carrier board hole
 - Blockage prevents water vapor removal
 - Water in “face volume” conducted HV to signal vias producing black gunk from circuit board and via material
- Several have evidence of mechanical interaction of window frame and optical connector

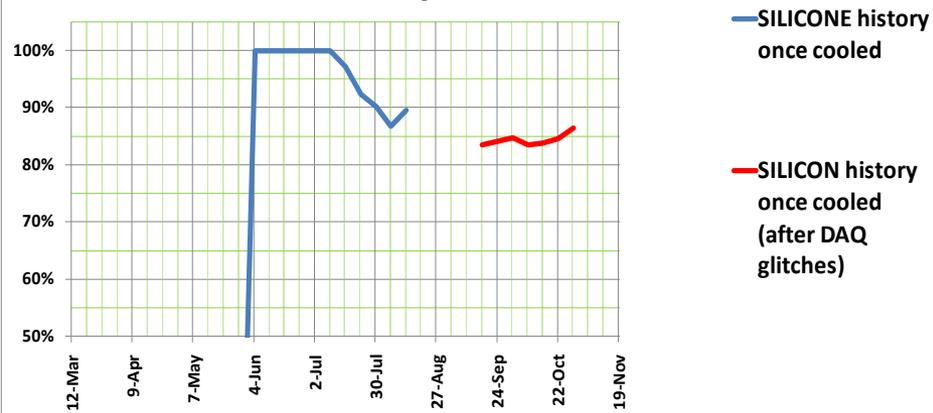
SILICONE history once cooled

- **Silicone**

- 178 installed
- 162 work cold after installation
 - 91%
- 140 continue to work cold today
 - Some after 26 weeks
 - 86% of those which initially worked cold
- 79% of the 178 installed

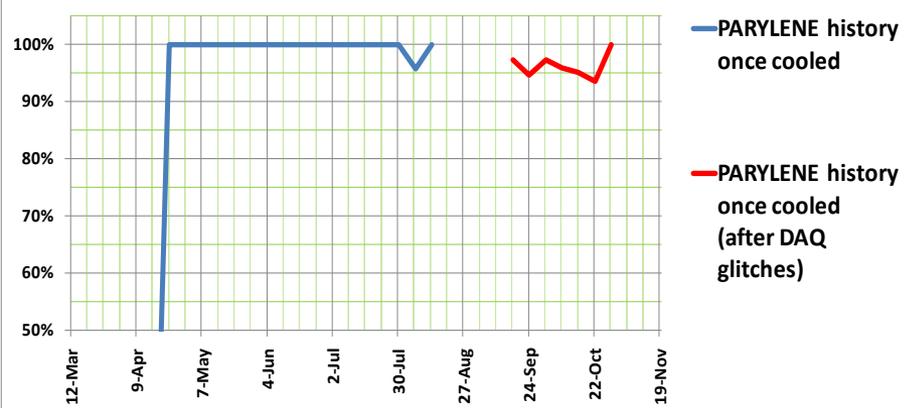
PARYLENE history once cooled

- **Parylene**

- 107 installed
- 92 work cold after installation
 - 86%
- 92 continue to work cold today
 - Some after 33 weeks
 - 100% of those which initially worked cold
 - But not necessarily the same ones
 - 86% of the 107 installed

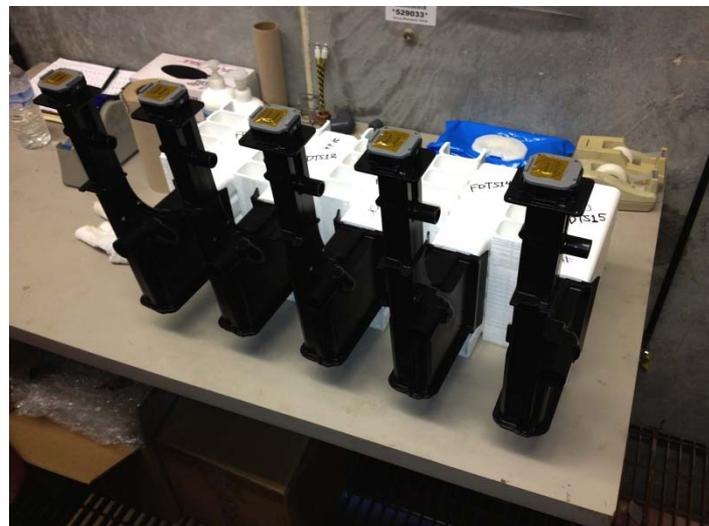
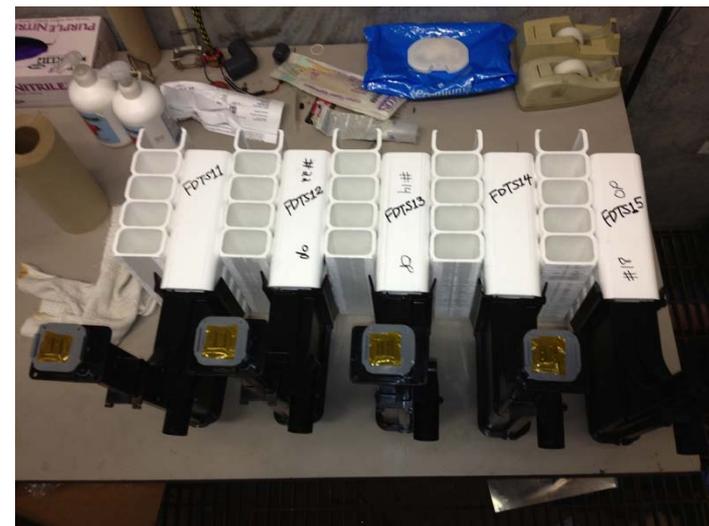
Final Installation test progress

- Mechanical parts have been assembled
- Plan for DAQ, power, water, and dry gas supplies in place
- Electronics and APD Parts shipped week of Nov 5
- Installation beginning week of Nov. 12
- Initial results ...

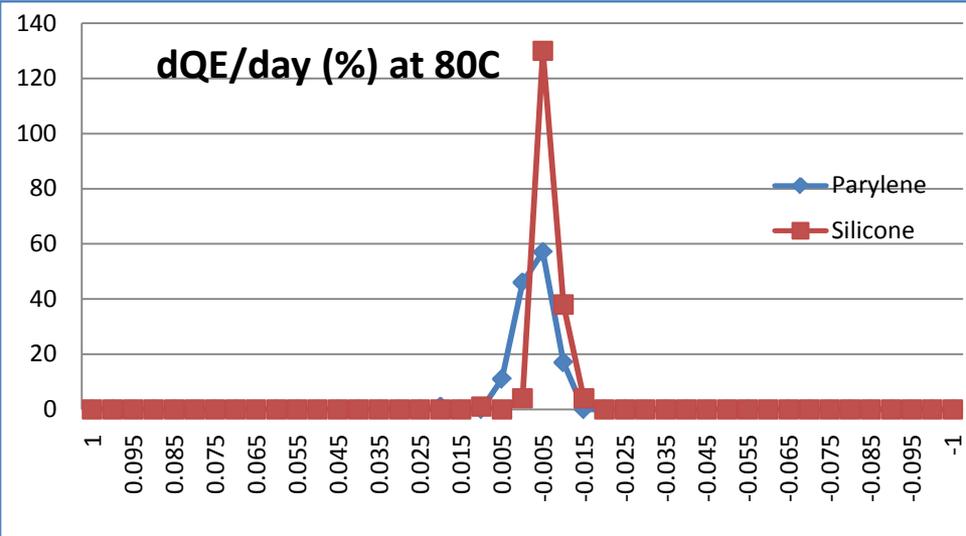
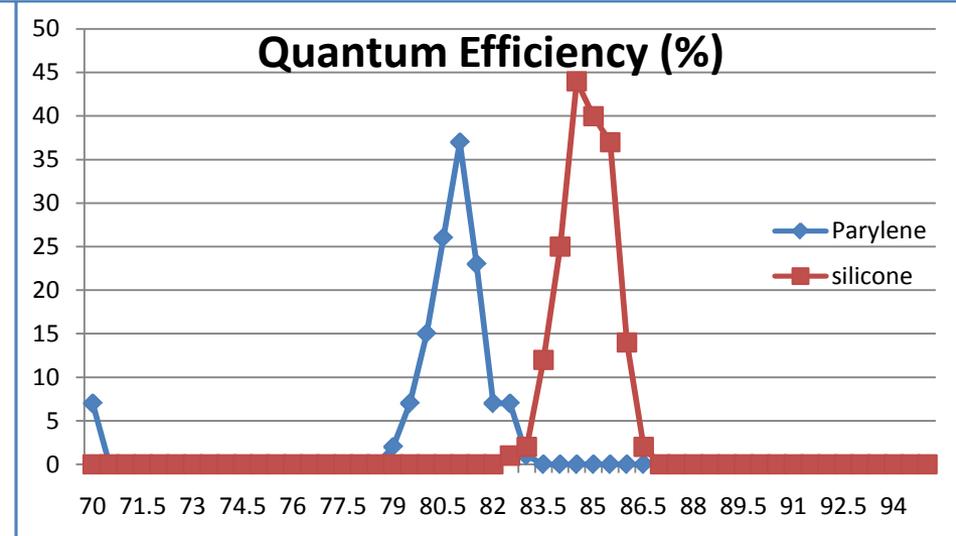
APD Coating tests

- Tests of aging of coatings at 80C for parylene and silicone coated APDs.
- 6 APDs of each type of coating
 - Chemical aging processes typically go 2 times as fast for every 10°C increase in temperature.
 - We have completed an 112 day test (as of 11/2/2012)
 - Relative to room temperature, this is approximately 20 years of storage
 - Relative to operating temperature of -15 C, this is 220 years of operation
 - Test with 523 nm light, about the middle of our spectrum
 - Average change was -0.005% /day for silicone, and 0 for parylene
 - Total change in 10years would be 0.025% change in QE for silicone and 0 for parylene
 - Also no visible evidence of discoloration or yellowing seen
 - Test continues
