# Nova Far Detector Assembly Report

Patrick Lukens

Fermilab

# Detector Assembly

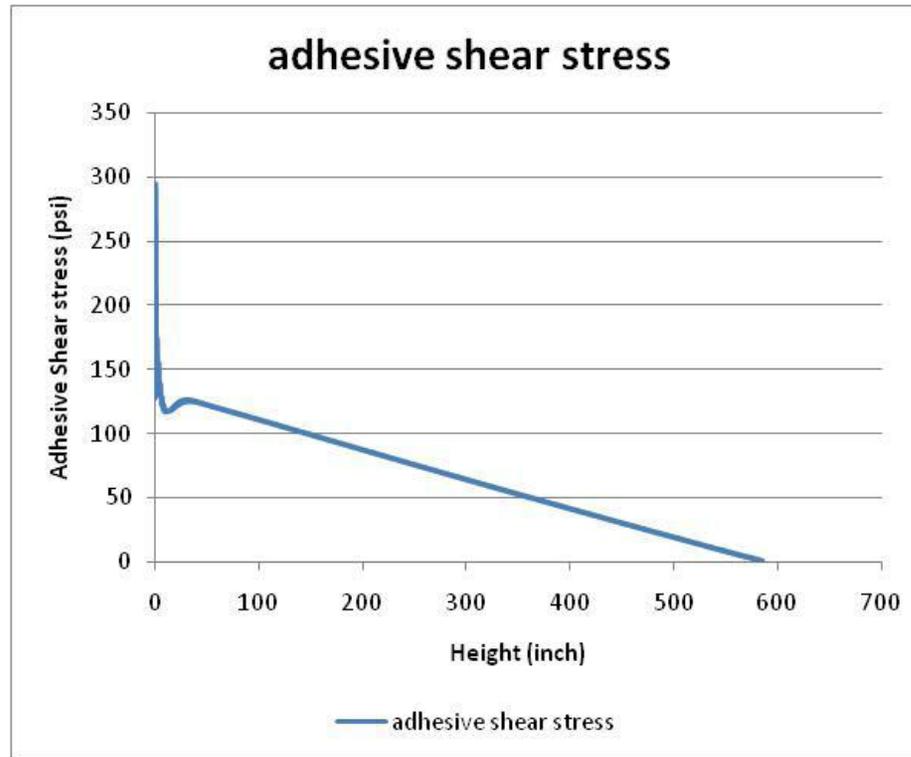
From Nova #5726

- Predicted maximum stress in the adhesive is 125 psi
- Predicted peel force is 9 lb./in.
- We established a 500 psi standard, based on desiring a safety factor of 4 in this stress.

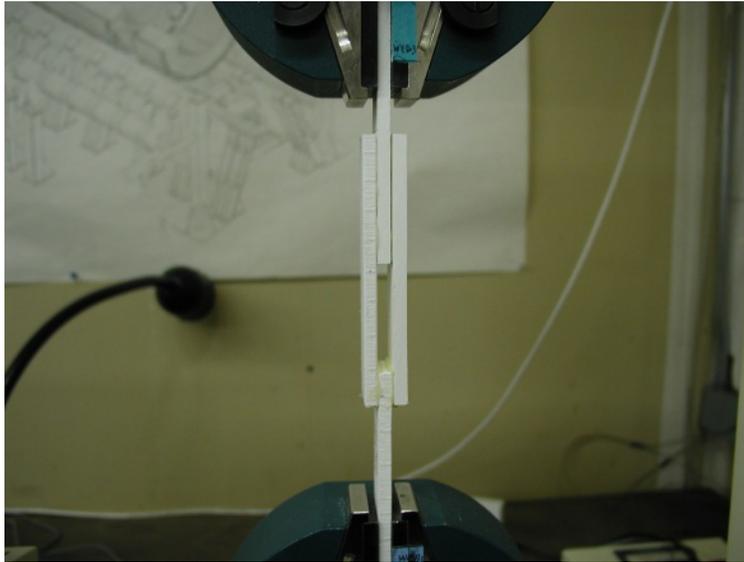
Shear sample under tension  
1000 psi shear strength seen

- Safety factor in shear is ~8, ~10 or more in peel.
- All glued surfaces will be scuffed with sandpaper
  - Considered to be very conservative, since stress declines with height.

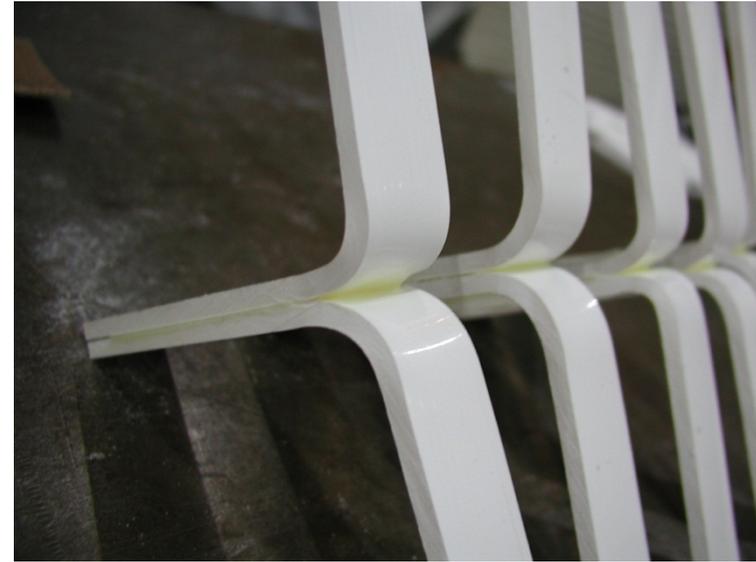
Peel samples  
100 pounds/inch seen

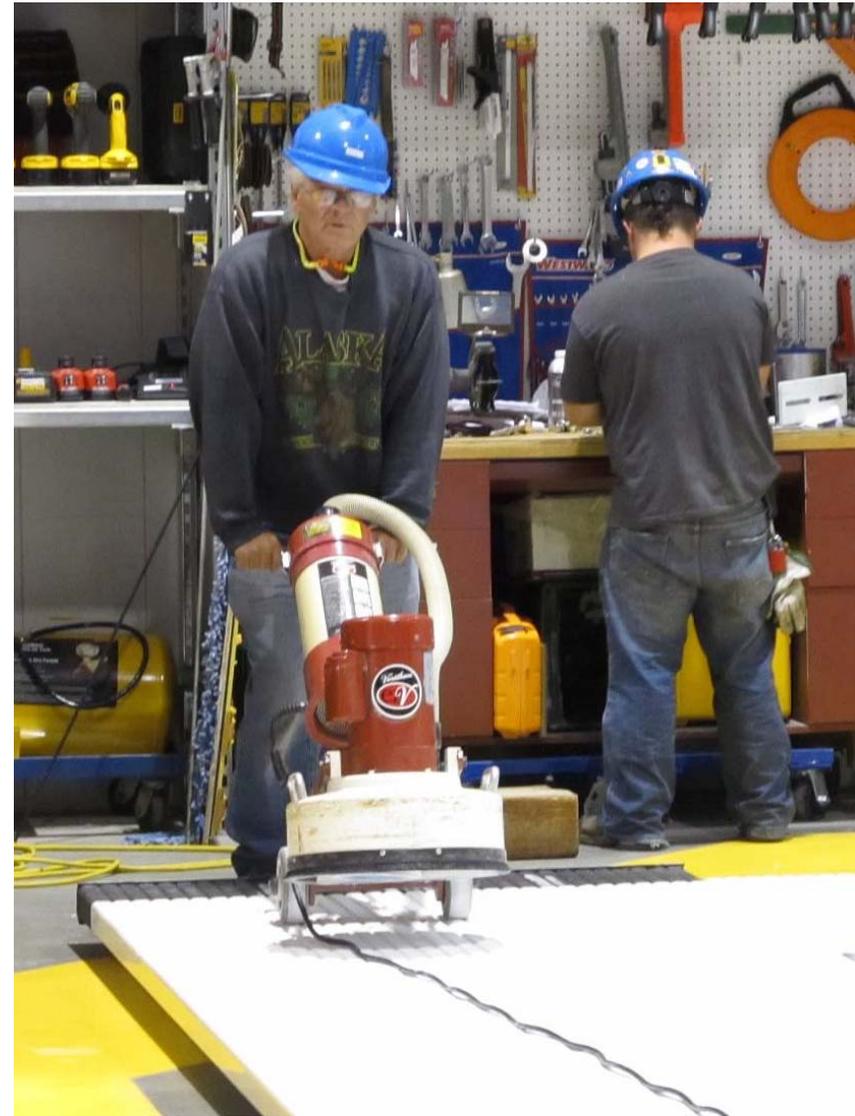
- Blocks are built with scuffing for all glued surfaces.
- For first 6 layers, leak and optical fiber tests were repeated after scuffing
  - No failures were found
- Current technique is a floor sander, 80 grit sandpaper.
- Probably ~40 minutes per module to sand
  - Requires crane to move, people to flip, space to work
- Not compatible with the Ash River assembly schedule.
  - Now mostly done in Minneapolis

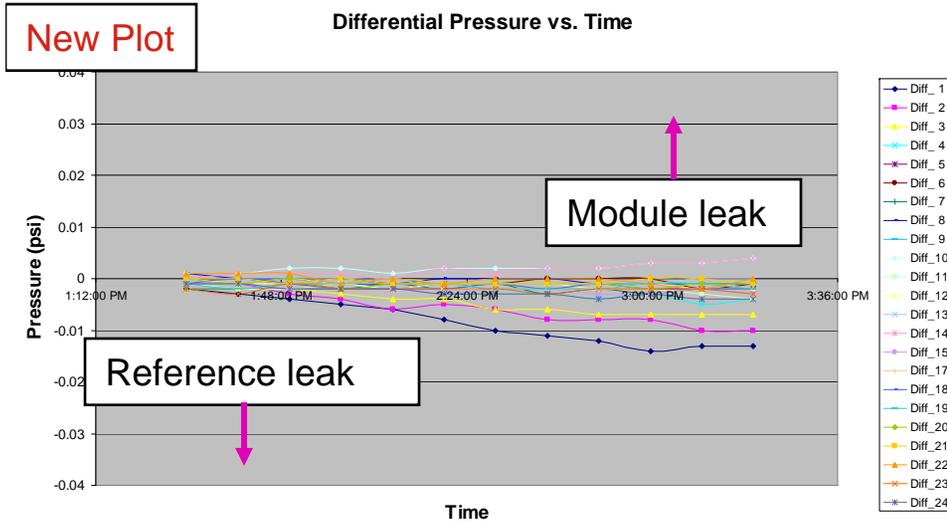
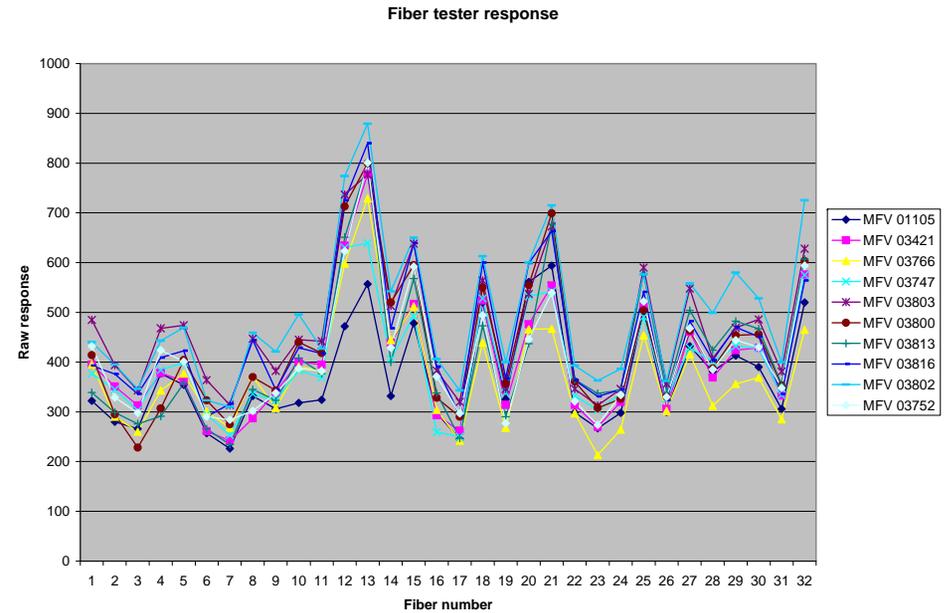
- A leak test is performed to test for shipping damage
- Pressurize, wait 2 hours, compare pressure loss to a reference.
- **0.02 psi/hr. (full scale here) corresponds to a 20  $\mu\text{m}$  hole**
  - **$\sim 1.5$  ml/week for a vertical**

- Optical continuity is checked for each module
- Broken fibers show no response
- These tests only confirm that shipping has not caused problems
  - More sensitive tests are performed at the factory.

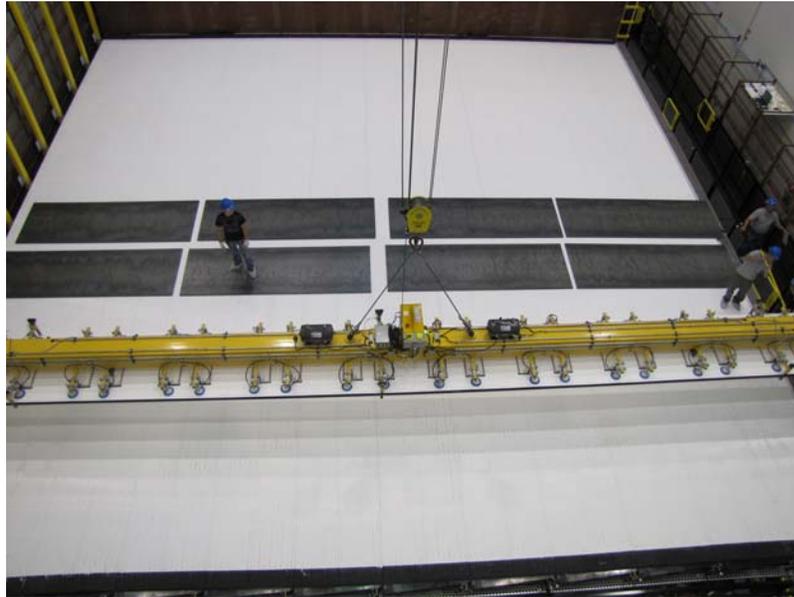
Module being positioned

- The assembly technique was developed at ANL
- Two multilayer “dry stack” exercises at Ash River

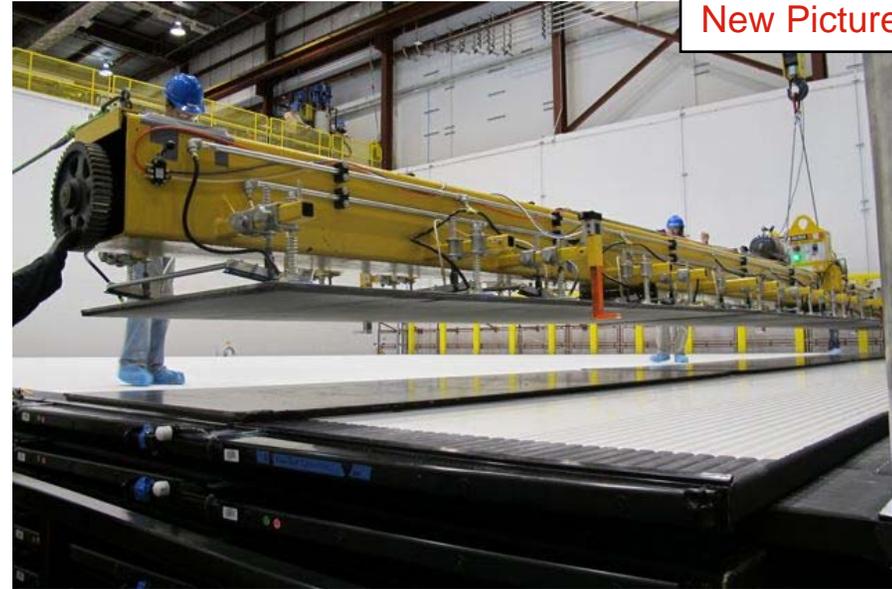
Compression plates for last module of Block 0

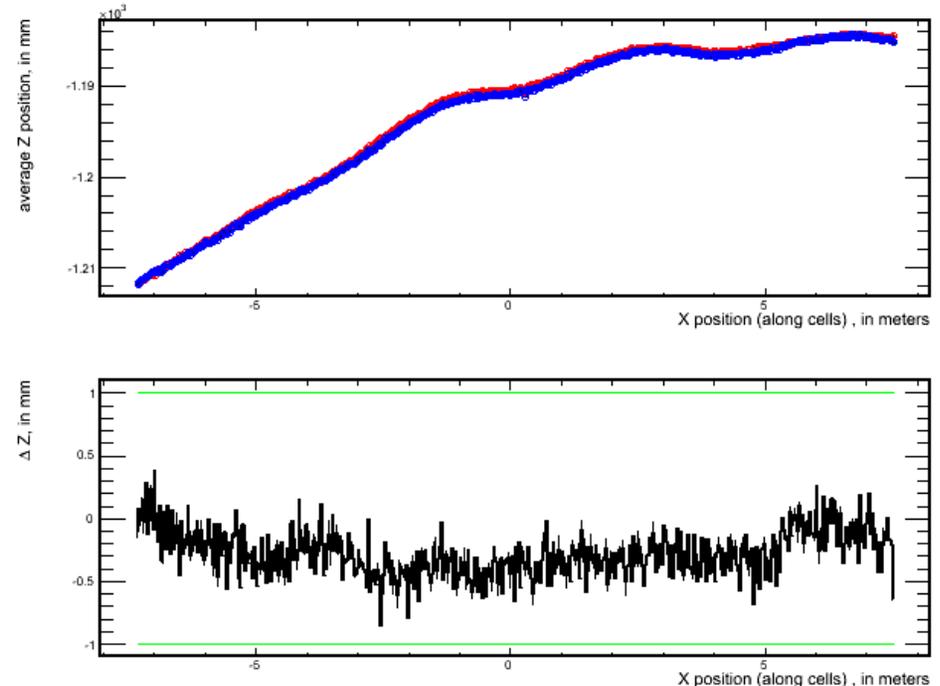
- After assembly, each layer is measured.
- Scanner data is analyzed by examining the relative heights of adjacent modules
  - Typical flatness check from Layer 14, Block 0.
- Laser scanner gives a height of channel 0 (blue) for one module, channel 31 (red) for the adjacent one.
  - We look at the difference
  - Green lines are  $\pm 1$  mm

- No problems have been seen with layer flatness
  - We're within our flatness specification

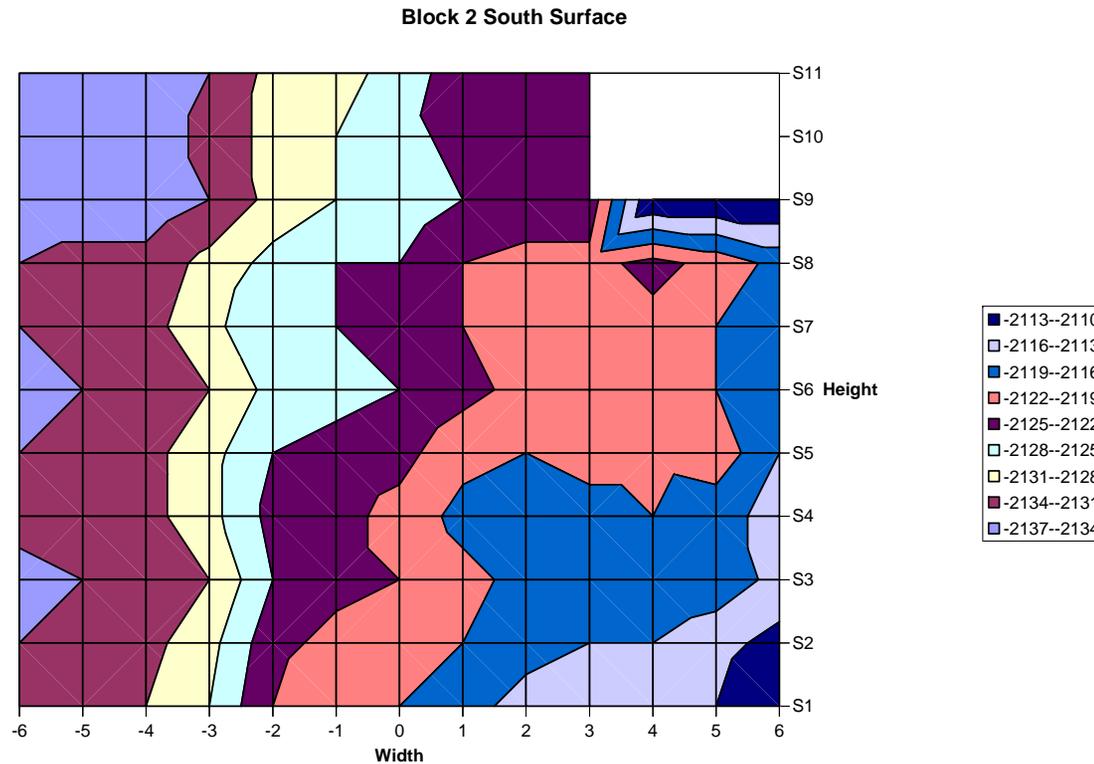
- Scanner data shows the shape of the block front face
  - Each band is a 3 mm range
  - 27 mm full range – the table top accounts for 16 mm

- The assembly table is flat to  $\pm 8$  mm
  - Specification was  $\pm 10$  mm
- Assembled blocks are flat to  $\pm 14$  mm
- However, the contour of the table is maintained through the layers of the block.
  - Thickness variation is small
- Contour of adjacent blocks is correlated, which allows us to achieve our desired (3 mm) gap between blocks.

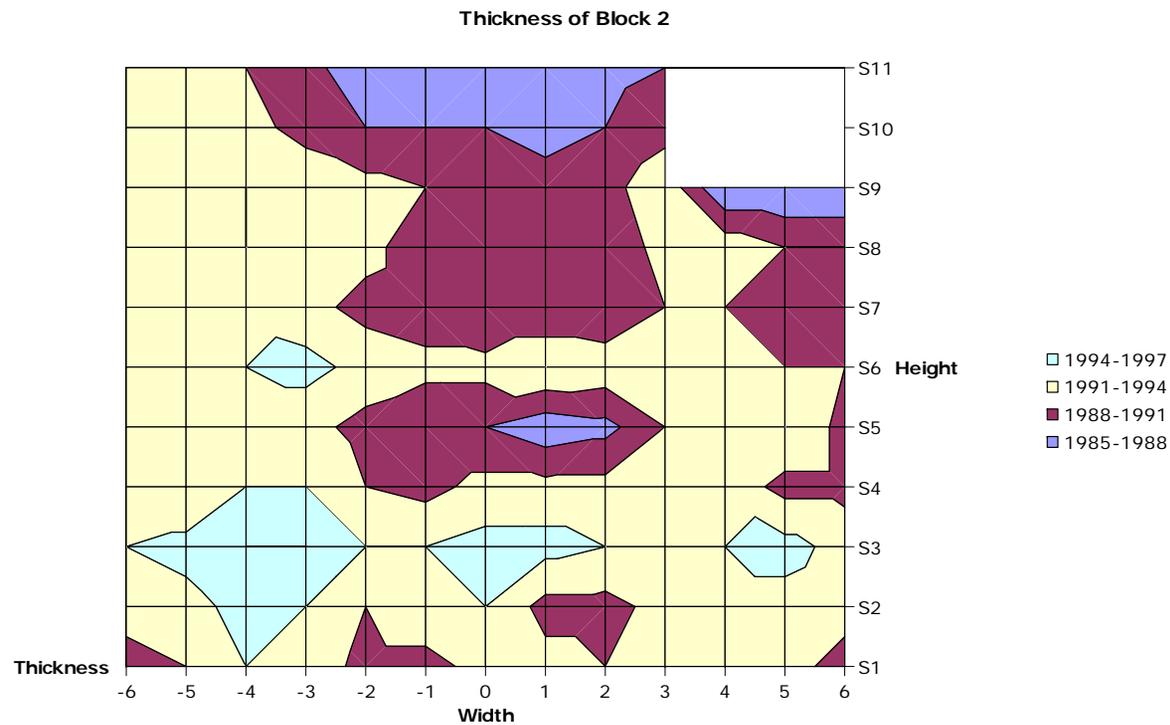
- The difference between Layers 0 and 30 give block thickness
  - Each band is a 3 mm range
  - Table contour tracks through the stack or 32 layers
  - $\pm 6$  mm thickness variation

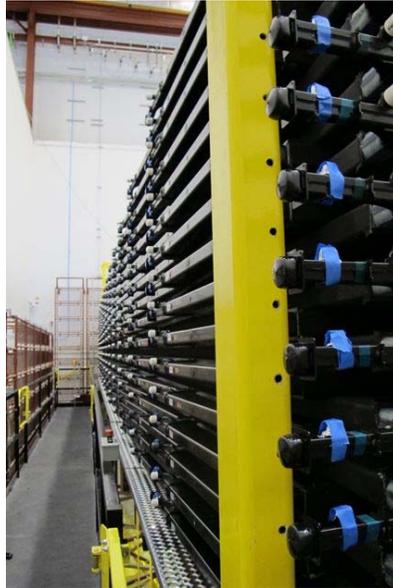
Edge view of  
Block 0

- The completed block contains 384 modules, 200 tons
- The assembly table, the Block Pivoter, drives the block 300 feet to the south, then positions it against the wall or previous block.

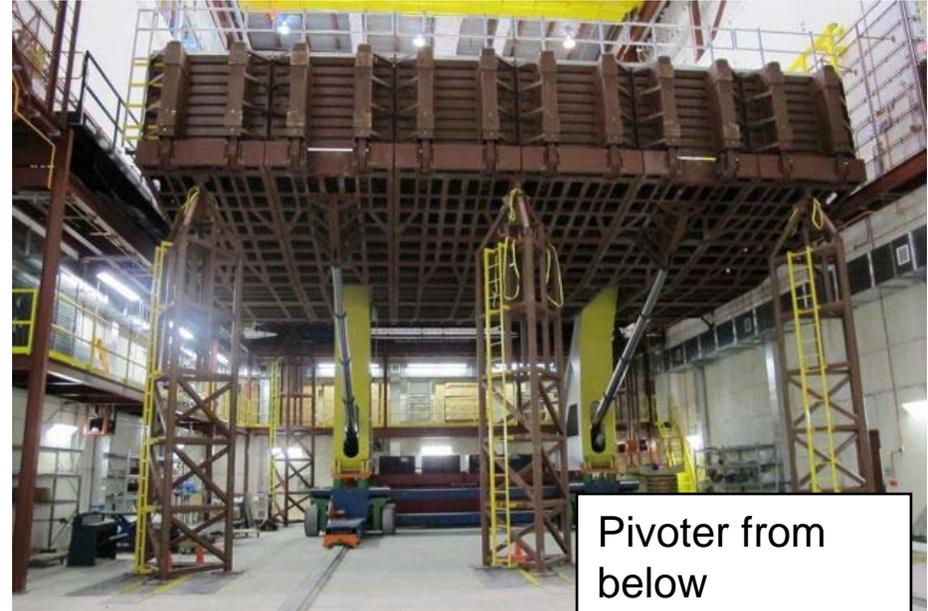
Pivoter from  
below

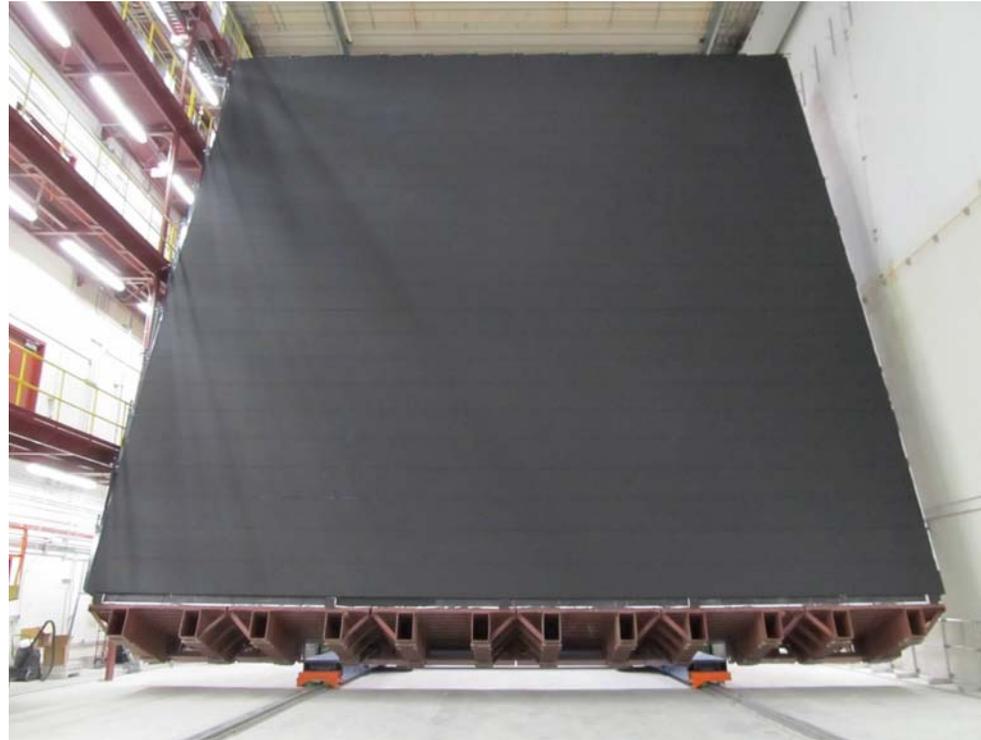
- Block 0 went in on 10 Sep.
  - Slowed, due to the drive being set for too low an operating pressure
  - A few components were changed, controls reprogrammed for the second block

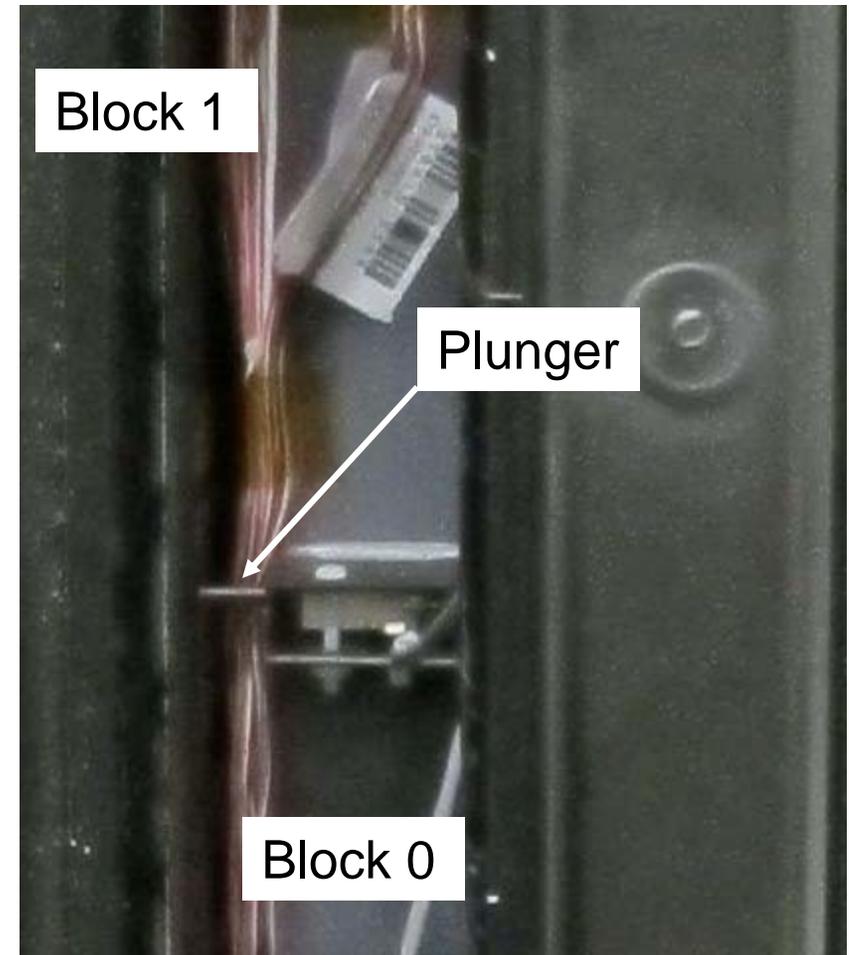
- Each block's position with respect to neighbors is measured with a plunger.
- These are used to monitor proximity in installation
- Long term motion will be monitored

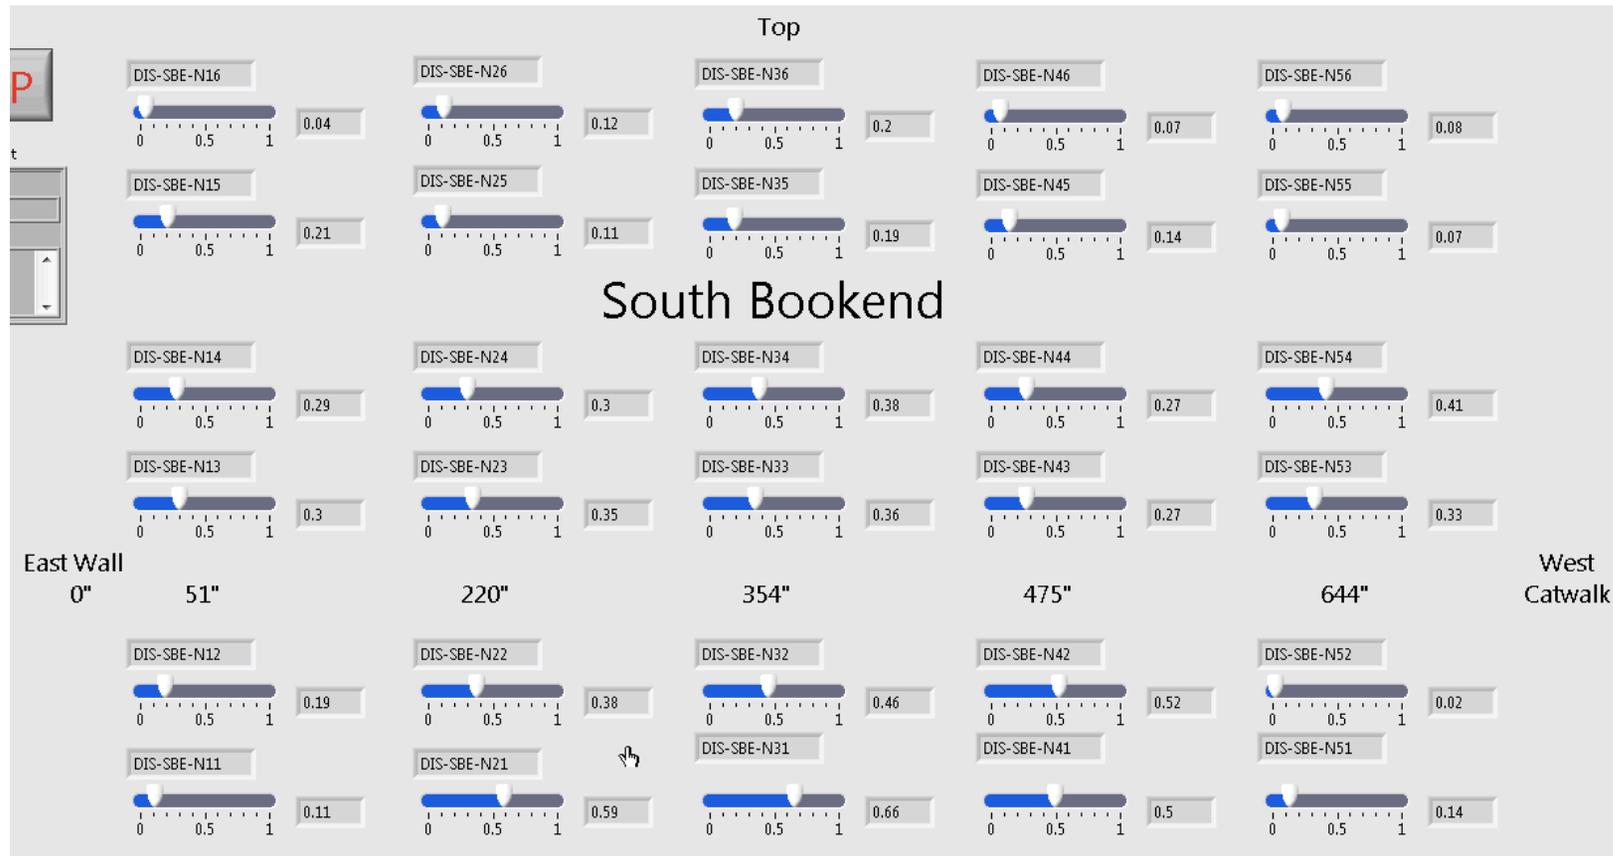
- Sensors show Block is hard to the bookend on the corners
  - Bowing in the middle.

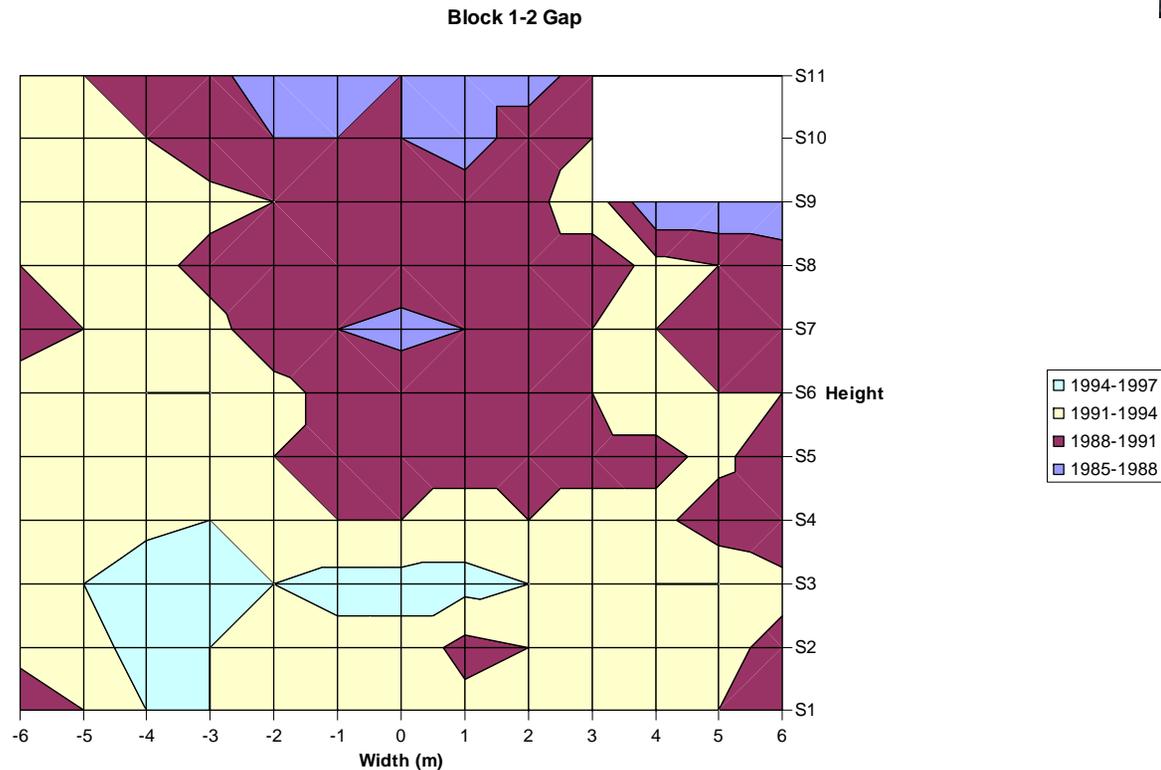
- Difference between Block 2 Layer 0 and Block 1 Layer 30
  - Shapes are strongly correlated – “Pringle affect”
